Huntington, Vt.

Community Tree Inventory

Trees on Town owned property

July 2005-April 2006

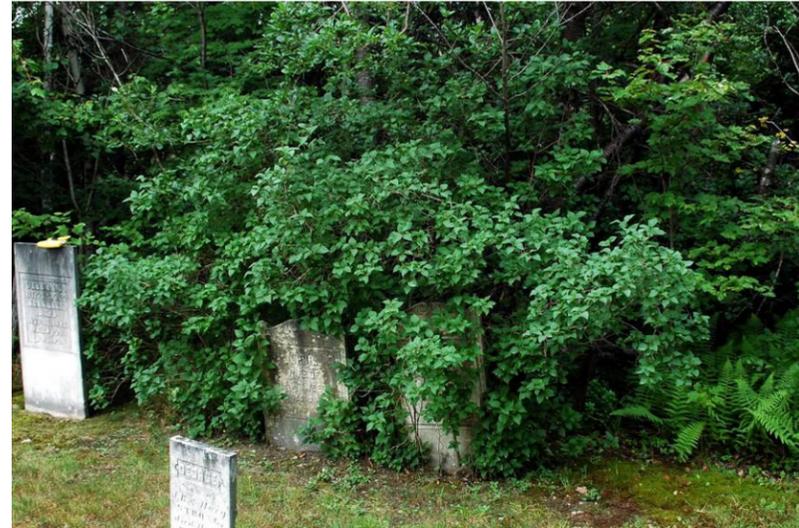
Figure d- engulfed monument at Hanksville Cemetery

eventually need maintenance or in some cases cause damage or envelop the associated or neighboring stone monuments and cemetery plots.

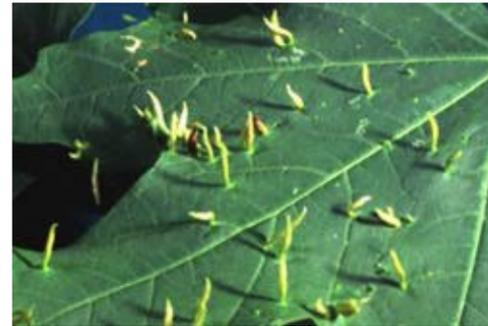
known and problematic forest pathogens such as Butternut Canker disease which afflicts the butternut trees found along the Huntington River at the Recreation Field. Trees in some locations are quite old and have reached their maximum species potential and are naturally in a state of decline. Other damage is the result of seasonal pests which are unlikely to cause any lasting or recurring damage to the trees such as Maple Spindle Gall observed on some leaves of Maples planted at Brewster Pierce School.

Figure f- maple spindle gall (<http://ohioline.osu.edu/hyg-fact/2000/2004.html>)

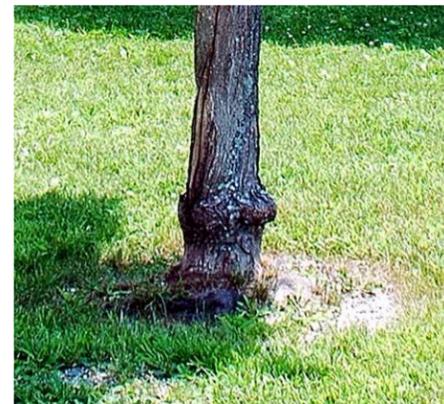
Figure e-multiple occurrences of trunk damage from mowing at BPMS

mulch or other buffers around the trunks of young trees occurring in lawn areas to prevent damage from closely operating lawn mowers or edge trimmer. Brewster Pierce School had the most evidence of damage resulting from moving activities, but all trees on all properties are at risk. We recommend the town adopt a policy on landscape management that includes specifications or allowed practices for mowing and

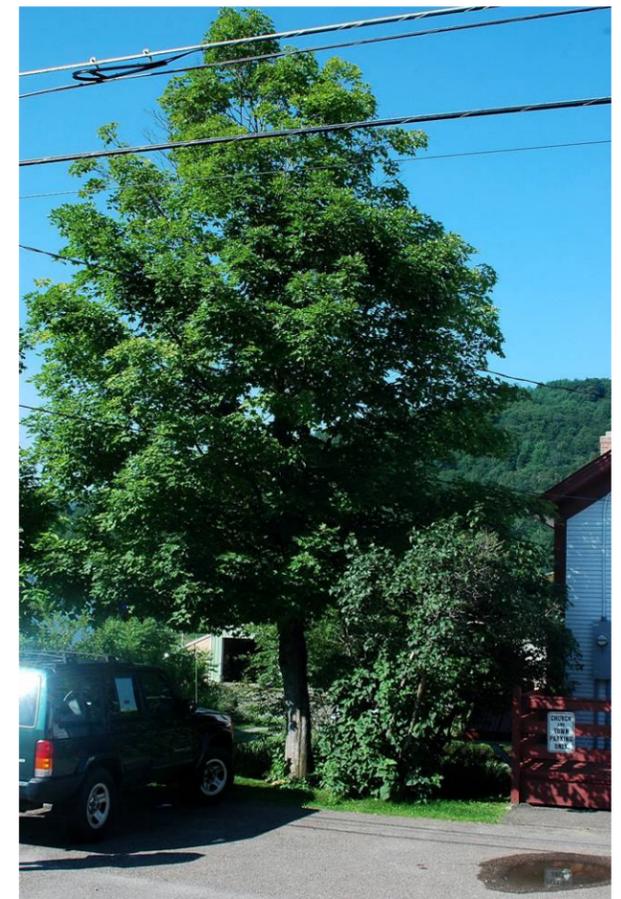
There were a few significant conflicts noted between trees and utility lines, buildings or road rights of way. Those of most concern occurred at the Town Office, in front of the building and at the Union Meeting House near the entrance to the driveway. Other current or potential conflicts occurred at the

Figure g- tree and powerlines at Town Office

Village Green and Fire Station. It is recommended that future landscape plans take these conflicts into account and adjust accordingly. Some trimming or outright removal may be essential to avoid damage to buildings

or utility lines, however it is recommended that any such activities be conducted with the input of the Huntington Tree Warden and the managing entity for the property in question.

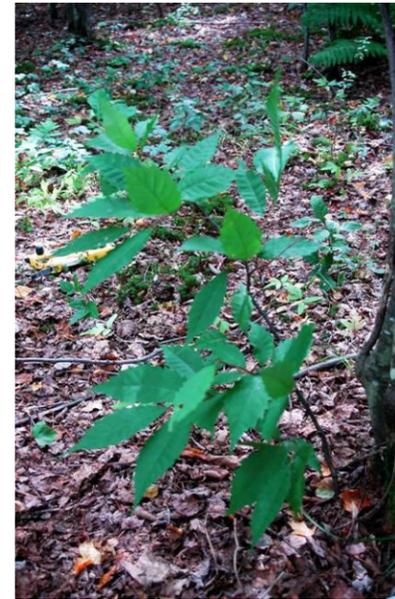
infection from Asia. There are only a few known mature Chestnut trees still alive within the State of Vermont. The roots, or sometimes a buried nut of the Chestnut persevere for some time after the death of a tree from the Blight, and will on occasion send up new sprouts. These trees will likely contract Blight before reaching maturity.

Figure i-Chestnut at Maplewood

While it is unlikely that the Chestnut found at Maplewood will reach maturity, it should be protected and nurtured on the off chance it does survive.

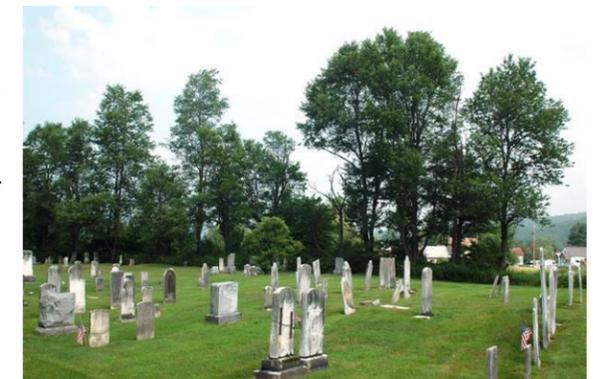
Figure k-northern property line hedgerow at Center Cemetery

many cases they provide an attractive edge definition to the property, but in some cases cutting is required to push back the advancing and aging forest.

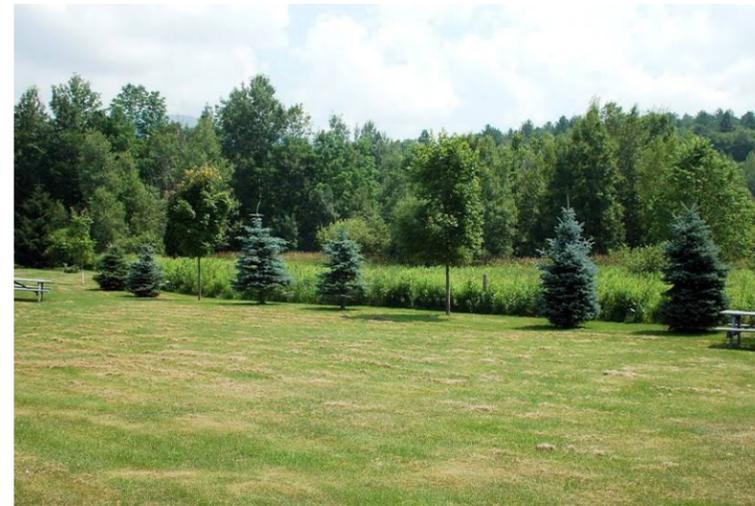
Unfortunately this town parcel seems to have more damage to its landscape plants than other town properties. This is primarily

Figure l-BPMS trees

trunk damage from careless mowing and in many cases is extensive enough to slow the growth and perhaps cause the death of important plants. This slower growth and potential for future failure from hidden wounds is not a desirable situation on this heavily used property and replacement planting should be considered sooner rather than later.

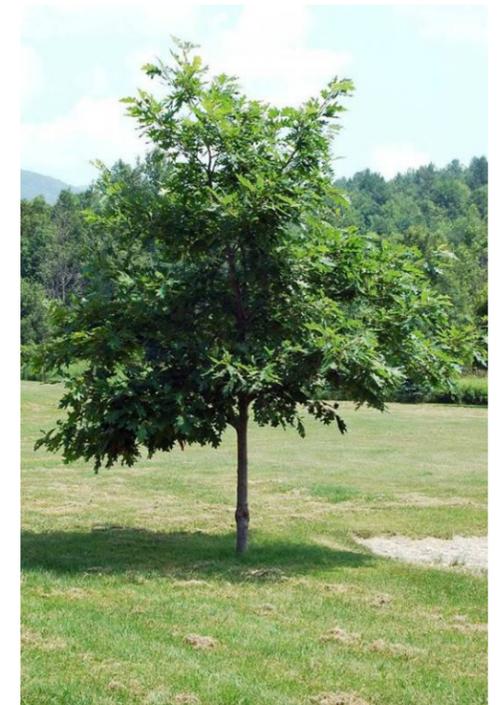
Figure n- Red Oak on BPMS playground

Two preliminary suggestions for improving this large open area are as follows; a thick hedge of evergreen trees on the north property line would cut the cold wind and extend the playgrounds use in the shoulder seasons, and a copse of large deciduous trees in the middle, near the damaged Red Oaks,

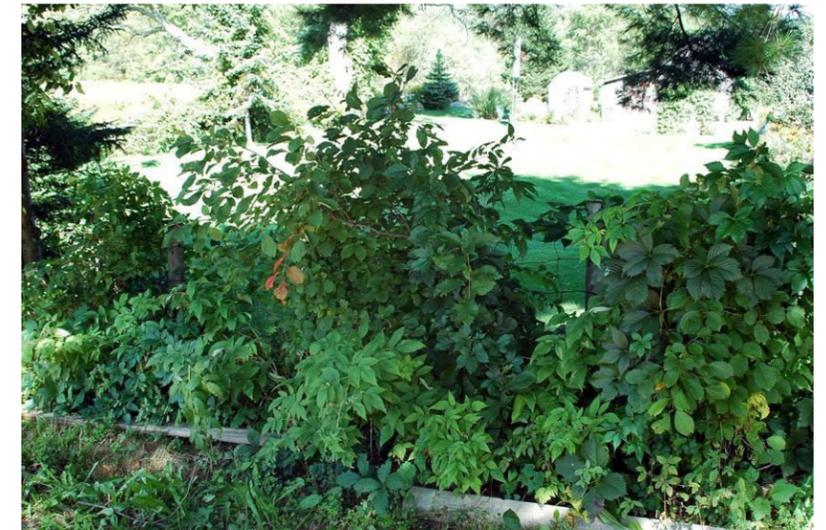
and subject to disease and dieback, there could be some significant gaps in the hedgerow in the not too distant future. Because tall trees look good here, care should be taken to protect any young saplings that may eventually replace the cherries. Any plantings to fill the voids should have height as a major requirement.

Figure t- small trees and other growth along UMH property line

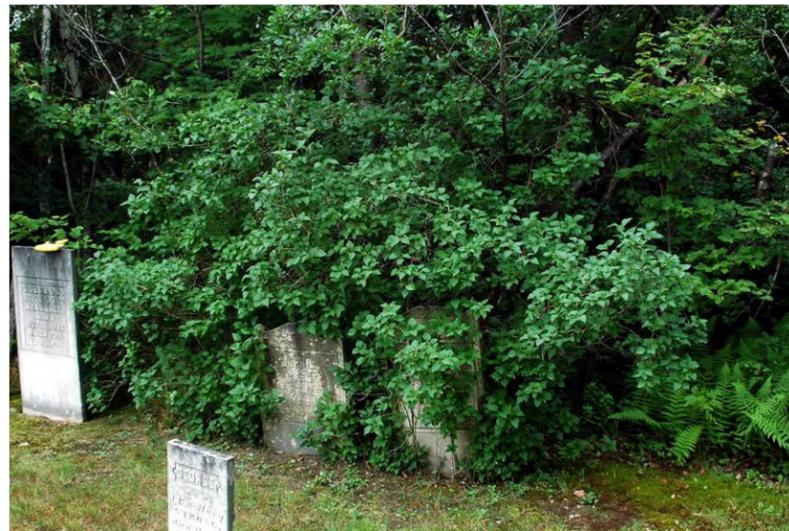
cover are indicators of poor soil conditions. The woods gradually encroach through an old woven wire fence onto the site but at present most stems have been cut back. Periodically clearing the property lines of encroaching stems is a good management objective.

Figure v- encroaching property line hedgerow, Hanksville Cemetery

This property would benefit from one major addition. To enhance the quietness and bygone era feeling that is so prevalent, a shrub border on the inside of the fence is recommended. This would block the view of the fence and mitigate some of the road noise, and also give some measure of privacy to those remembering their dead. In keeping with the historical character of this spot the shrubs should be traditional specimens and not modern cultivars. In addition the shrub height should be in the four to six foot range to block the fence but not make the cemetery seem any smaller than it already is. A traditional Spirea would work well here, but there are other options as well.

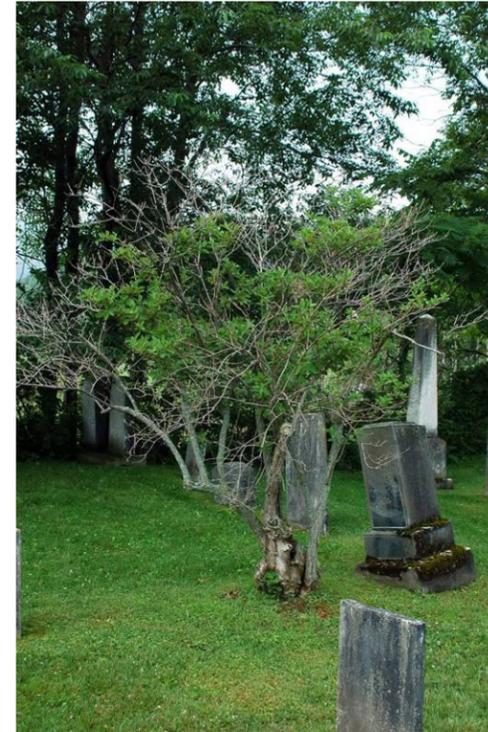
The only plantings in the western half of the cemetery are Hydrangeas. None of these are in good shape and the removal of all three is recommended. This western half is surrounded on three sides by tall hedgerows of mixed native species. Maintaining the property lines by cutting back encroaching stems should be the prime maintenance objective.

Figure y- Hydrangea at Center Cemetery

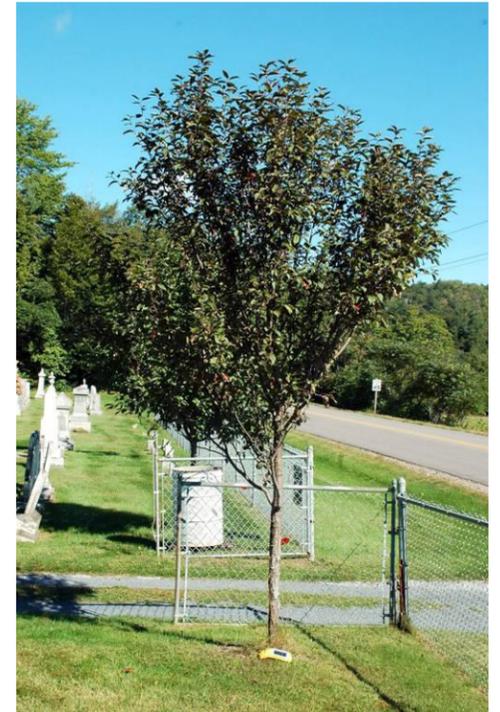
There are two Crabapples framing the entrance gate to the property, these seem somewhat confusing as they appear to be of different varieties. Because Crabs grow out as much, if not more, than up, they are likely to interfere with vehicle access to the Cemetery at some point in the future.

Figure bb- Crabapples at entrance

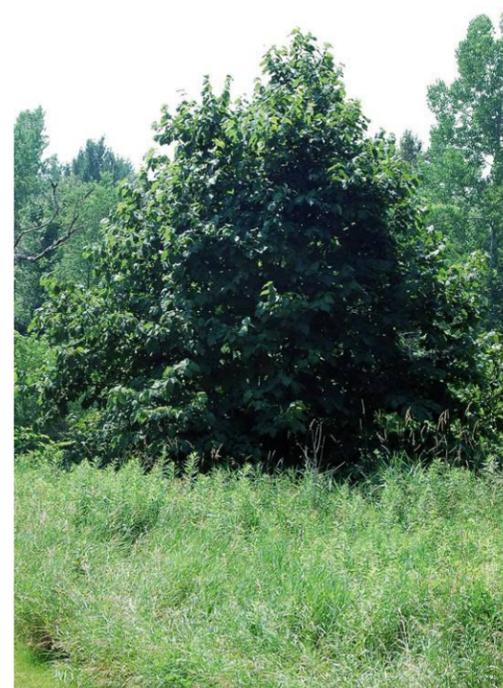
apple trees on the lawn, good accents creating good useful space. And a healthy looking White Cedar hedge on the north property line helps define this area. We noticed that vines growing in the Cedar hedge would soon need attention if this asset were to be saved.

Figure dd- Basswood along Huntington River

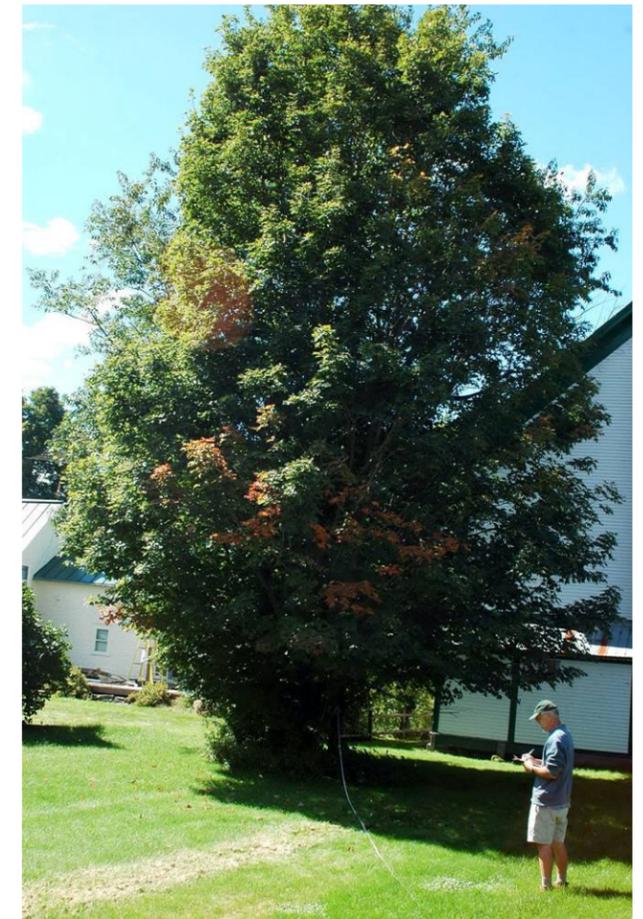
The Town Hall property is small and contains only four trees, all growing together in a little copse. One of the smaller Sugar Maples has major trunk damage and should be removed. The large Black Cherry shows some signs of damage and will need periodic maintenance in the future.

Figure ii- group of trees behind Town Hall
