TOWN OF HUNTINGTON, VT

**MAIN ROAD
PAVEMENT EVALUATION STUDY**

**DuBois
& King
inc.**

FEBRUARY 2012

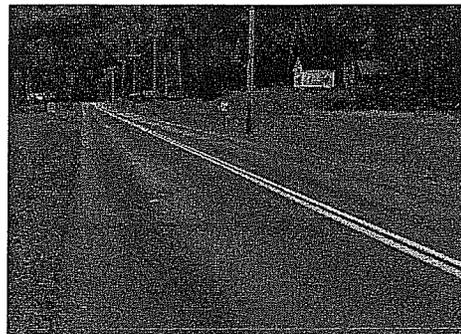
This column provides an estimate of the amount and severity of transverse cracking within the roadway segment. Transverse cracks run across the roadway and are perpendicular to the centerline. They can be caused by thermal expansion/contraction of the pavement, or by cracks or weaknesses in the road base (such as a culvert without sufficient cover or joints in a lower pavement layer).

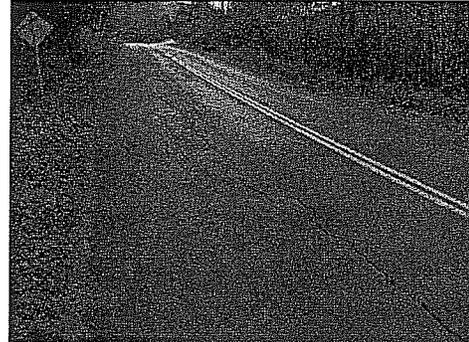
This column provides an estimate of the amount and severity of longitudinal cracking within the roadway segment. Longitudinal cracks are cracks that run along the roadway parallel to the centerline. They can be caused by improperly constructed joints or by vehicle loading.

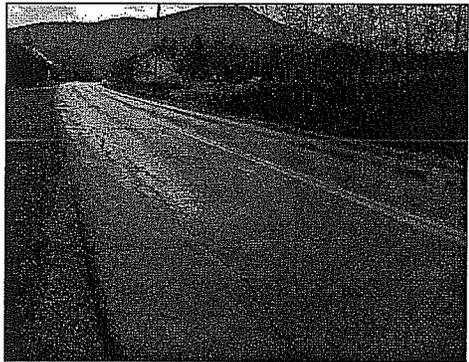
This column provides an estimate of the amount and severity of shrinkage cracks within the roadway segment. Shrinkage cracks are formed when the binder material in bituminous concrete pavement breaks down over time and separates from the adjacent pavement. These cracks are due to forces inside the pavement, not loading, and generally form blocks that are several feet across. Shrinkage cracks are usually associated with older pavement that has weakened due to exposure to the elements.

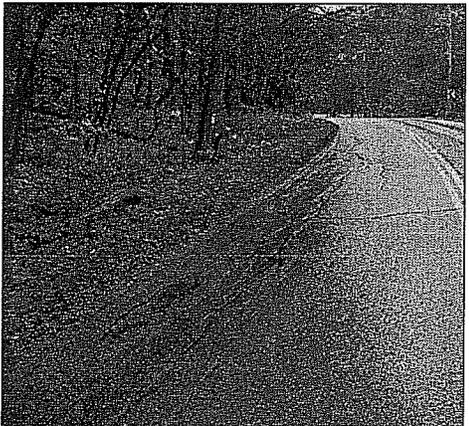
This column provides an estimate of the amount and severity of rutting within the roadway segment. Ruts are deformations in the roadway where the pavement surface is depressed below that of the adjacent pavement. Ruts run parallel to the centerline and are generally caused by compaction of

the pavement/base materials or by the lateral displacement (shoving) of the base materials.

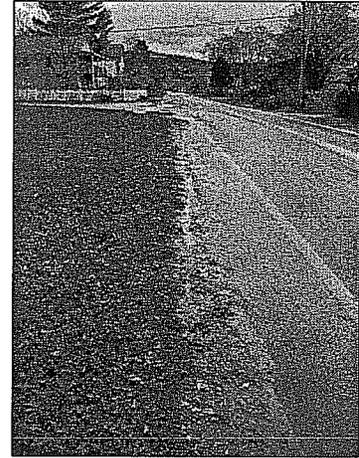
This column provides an estimate of the extent and severity of drainage problems within the roadway segment. It includes the ability of water to drain from the road surface as well as the ability of the surrounding area to drain water away from the roadway. Standing water, ditches, erosion, culverts and slopes were all considered as part of this metric. Water is a contributing factor to many of the other pavement defects, and saturated base materials can severely impact a road's ability to carry vehicle loads.

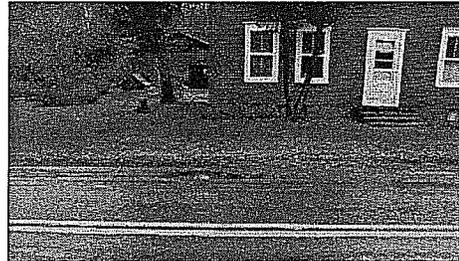
The alligator cracking found on many roads is often associated with saturated base materials. Not surprisingly, areas with alligator cracking often lacked ditches or other means of drainage. Ditches should be established and regularly maintained along all roadway segments in order to maintain or improve the service life of the road. In areas where open ditches are impractical due to surface constraints, subsurface drainage solutions such as subbase drains should be considered.

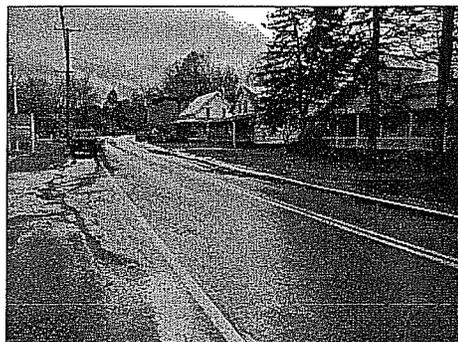
Several areas in which drainage conditions affected the roadway were observed. Three basic situations were observed: areas where wetlands or standing water were adjacent to the road; areas in which lawns or ledge prevented an adequate ditch from being maintained; and the undefined drainage paths found in the Lower Village near Beaudry's Store.

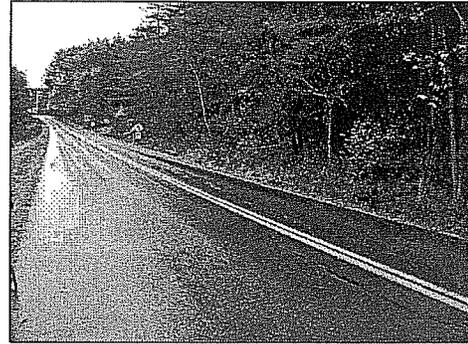
Some areas adjacent to wetlands showed longitudinal cracking which indicated that the road base was too weak to handle traffic loads at the time of cracking. This may

be a problem that varies as the water table fluctuates, and materials may have consolidated since the crack formed and the base could now be strong enough to resist cracking.

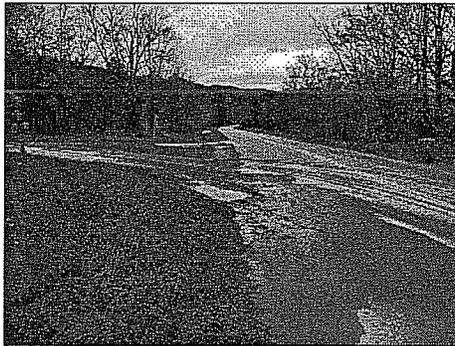
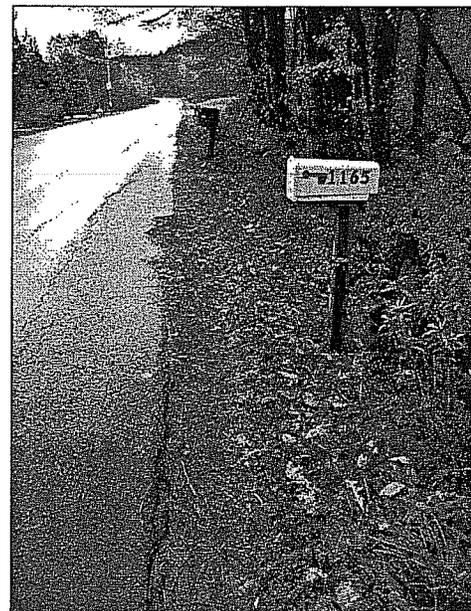
The presence of driveway aprons varied throughout town. Paving aprons at areas where extra wear is expected on the edge of shoulder due to vehicles entering and exiting the roadway acts as a sacrificial barrier to protect the traveled way. On gravel driveways, placement of an apron also helps to keep potholes and gravel from affecting the highway pavement. In addition to driveways and roads, aprons should be considered in areas where vehicles are anticipated to travel off the paved roadway, such as at mail boxes or pulloffs.
