An Inventory of Road Drainage Problems

On Class 3 Roads

And a Capital Improvement Plan

Town of Huntington, VT

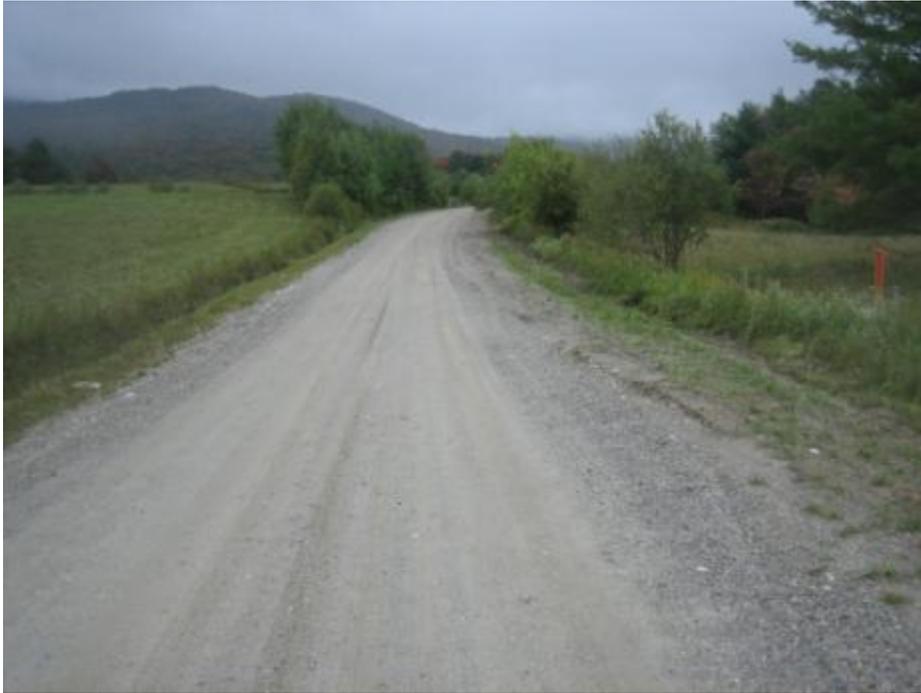
Roadside gravel could be pulled in as the operator shapes new ditches. In this instance the wire fence conflicts with the ditch line.

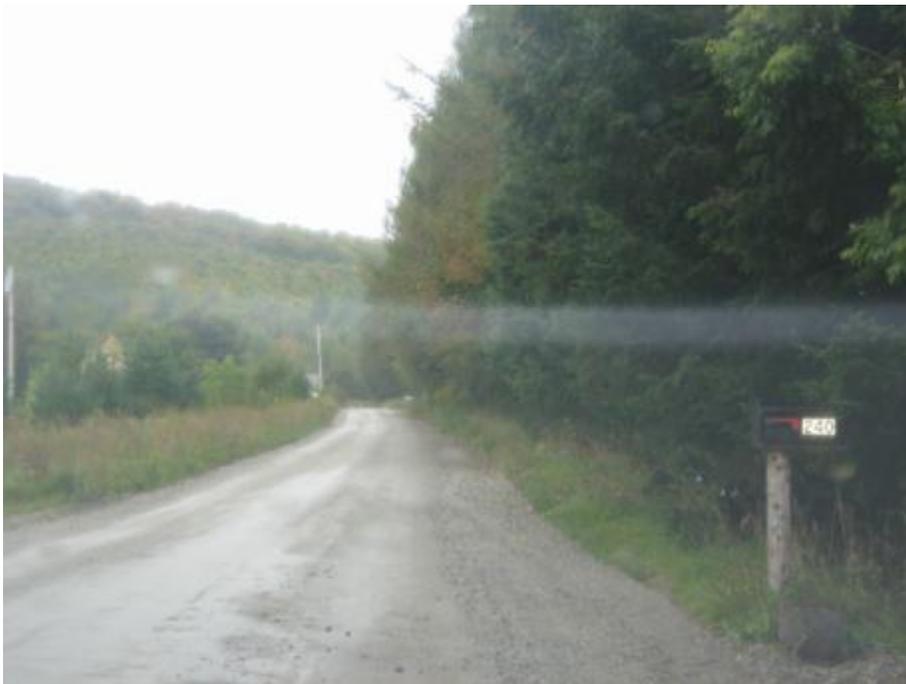
Flat roads such as this are typical. Notice where water flows and the accumulation of soil on the roadside.

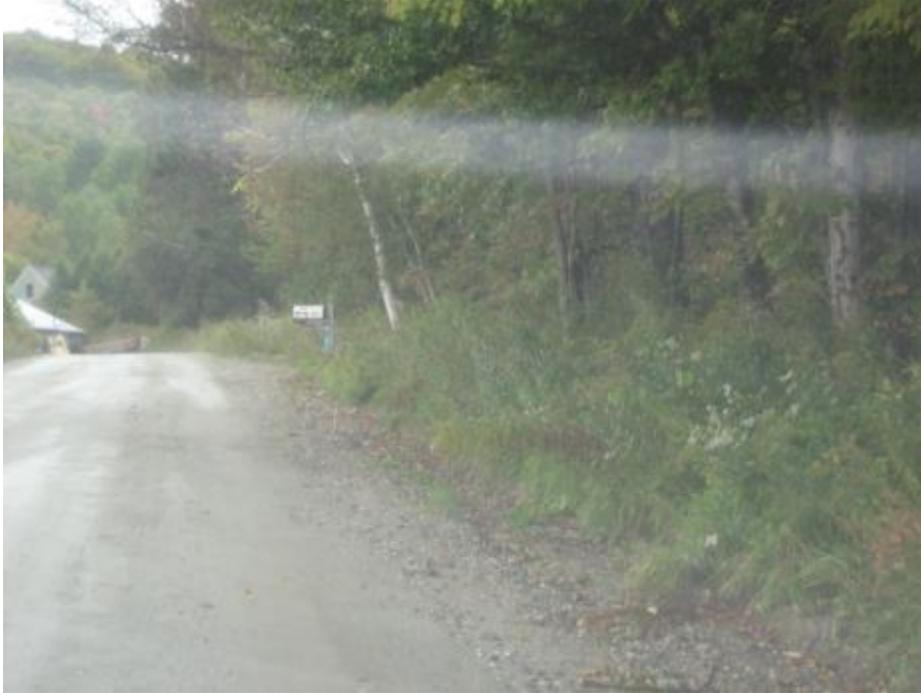
Similar to previous photo.

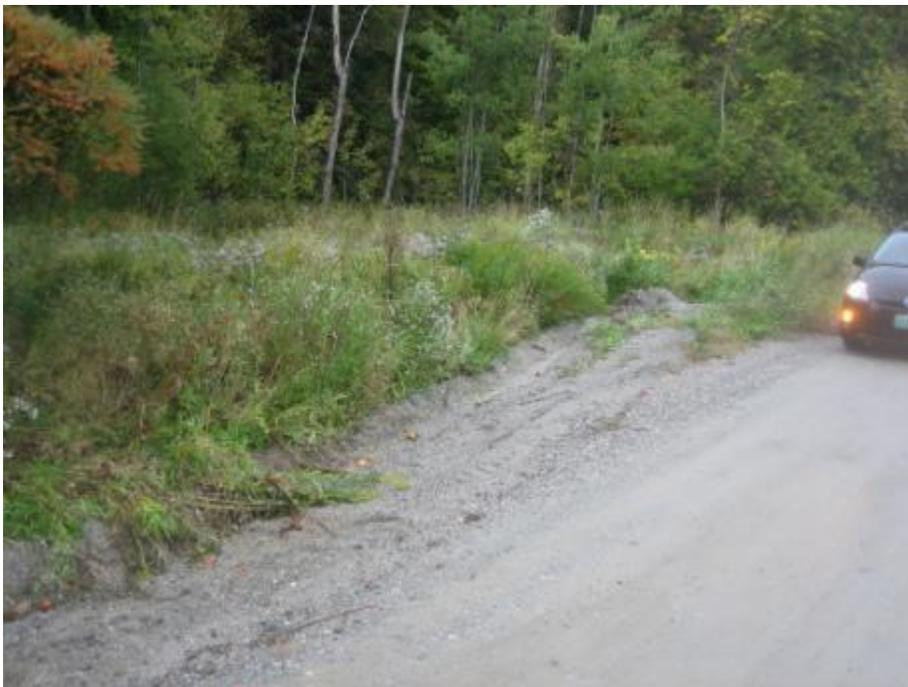
A turnout with much useable gravel. For all turnouts, reshape and line with stone and reclaim gravel where possible.

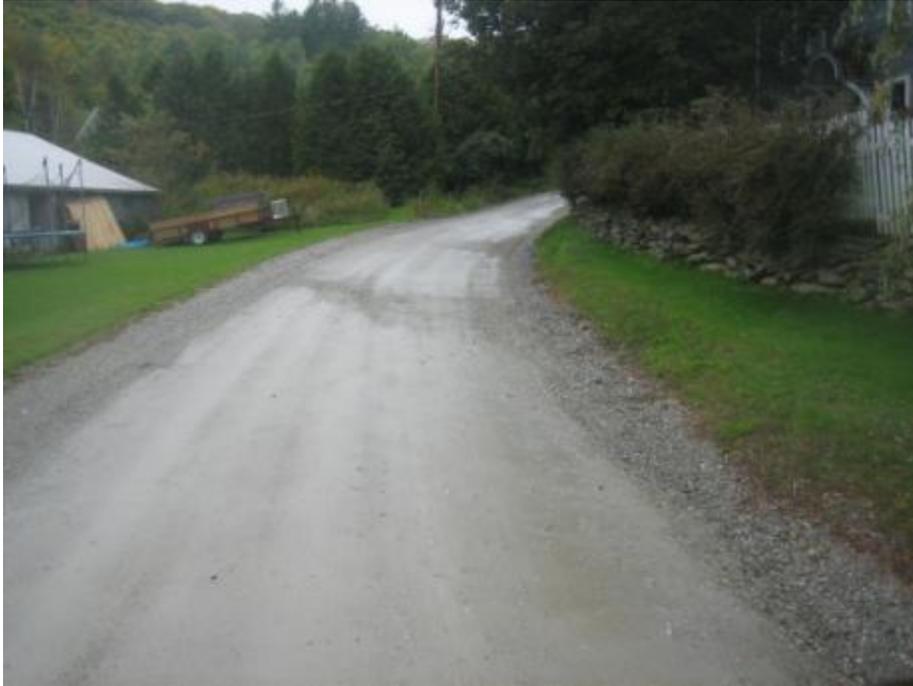
Notice how water flows in the road, carrying material downhill. Note the berms on each side of Beane Road that direct surface water onto the road.

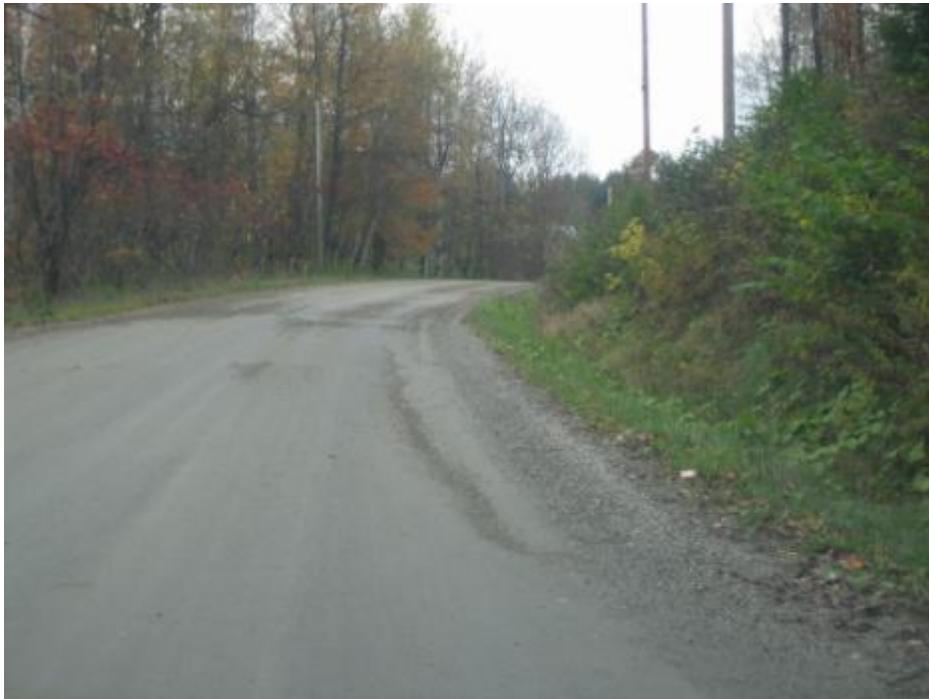
Note where water flows at this point on Bridge Street.

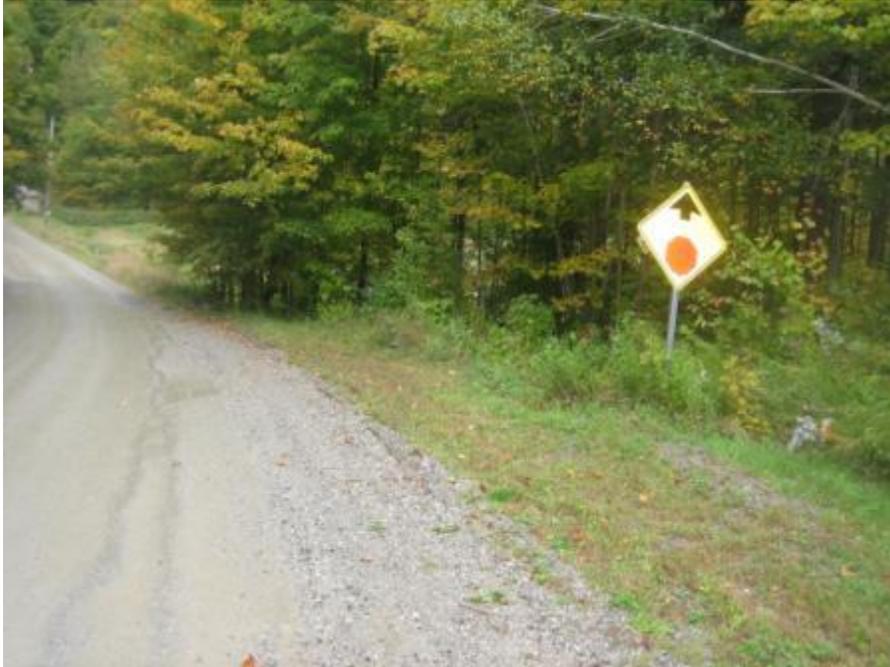
Water flows in the road. Note gravel accumulation. (Lower Carse Road)

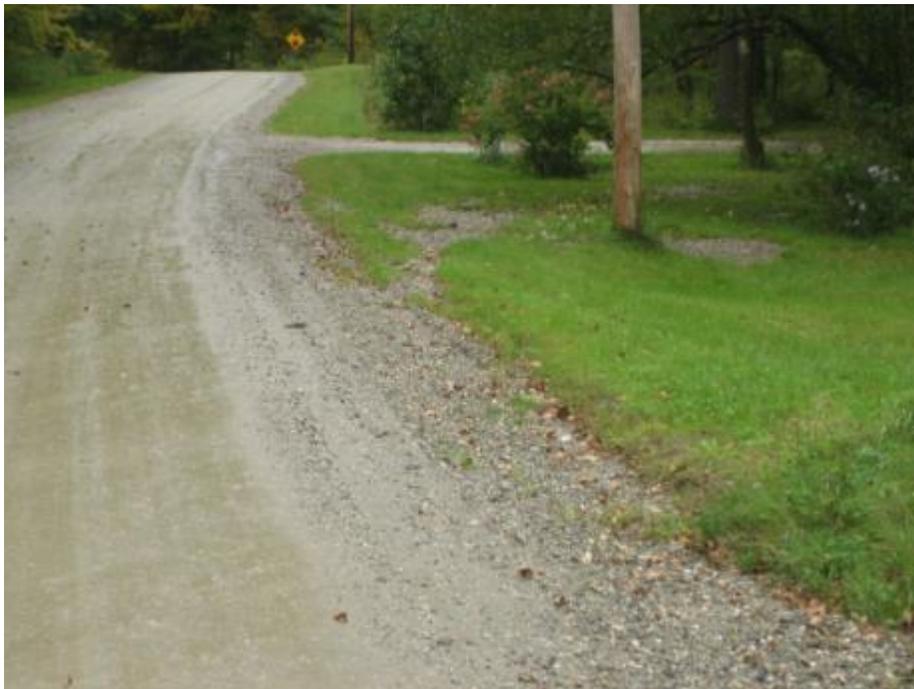
On Carse Road, consider placing a new culvert to cross water under the road to the south side into vegetated areas and away from this property.

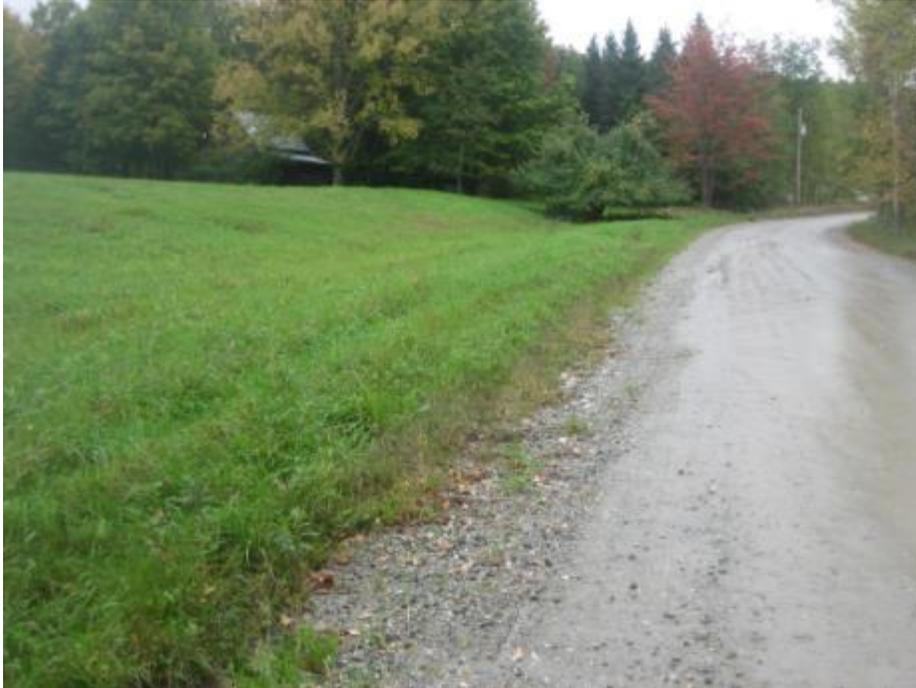
Typical washing of water in the road. Need to remove berm, reclaim material, construct shallow ditch and line with stone. (Lower Carse Road)

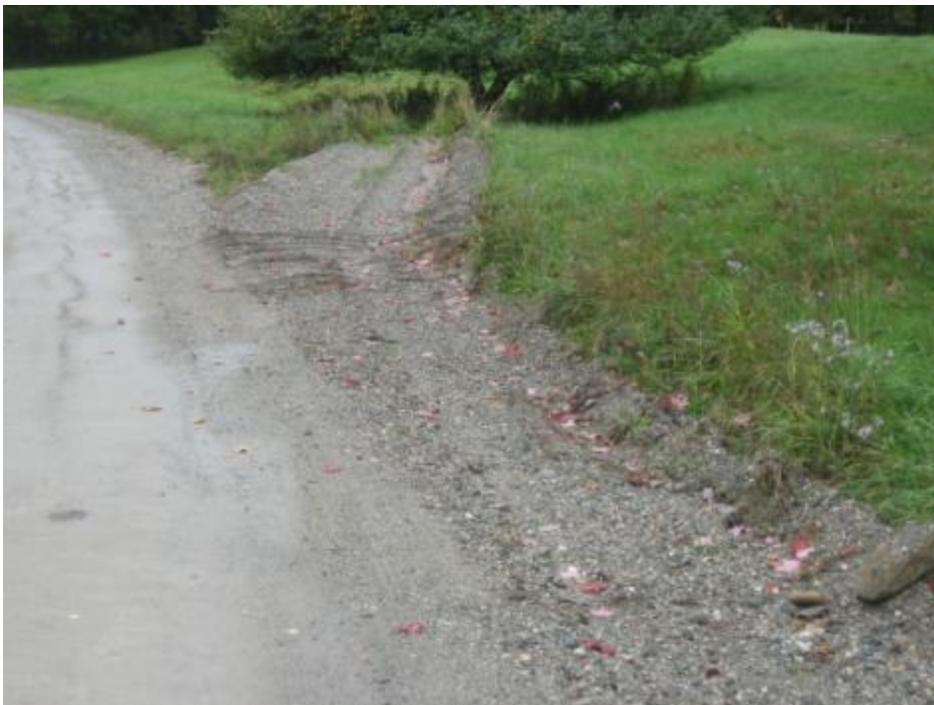
Another turnout with excess gravel. (Carse Road near utility pole #330)

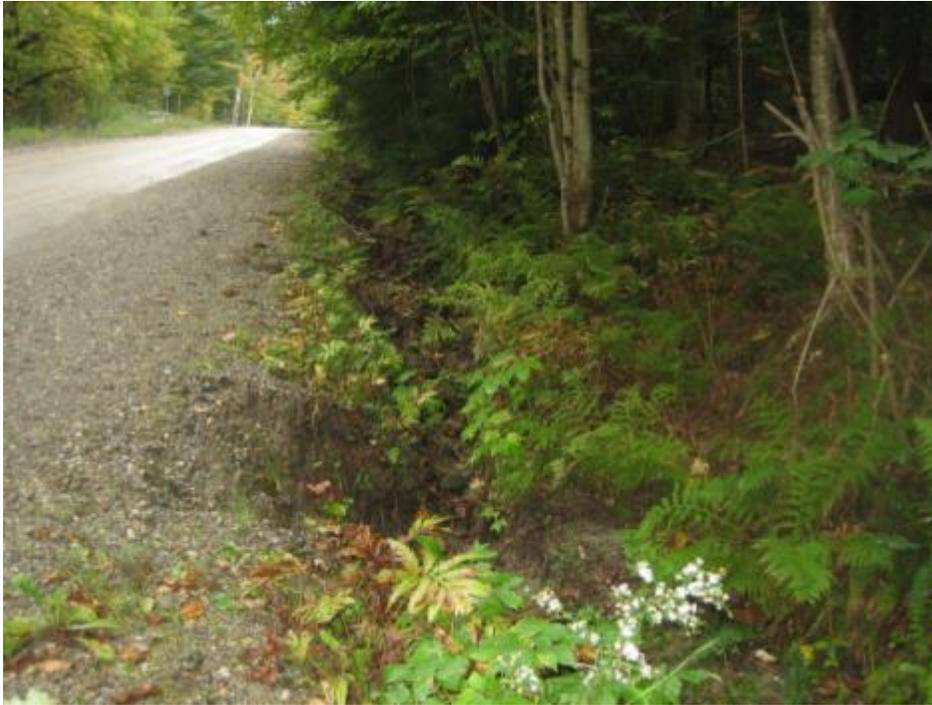
Severe erosion. (Carse Road, up from intersection with Moody Road)

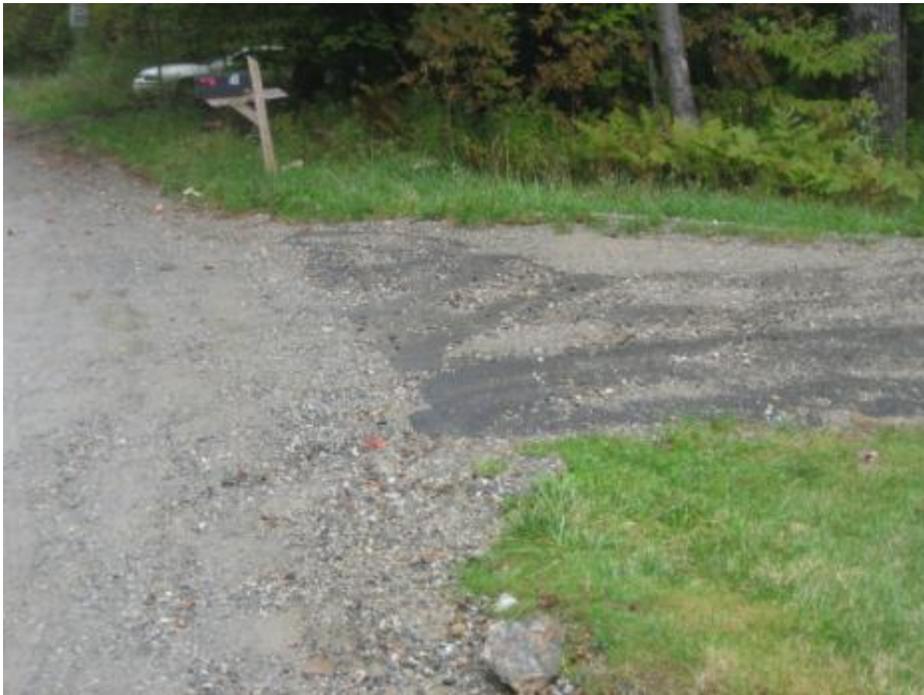
Evidence of erosion and deposits of gravel. Work with property owner to place culvert under driveway. (Carse Road)

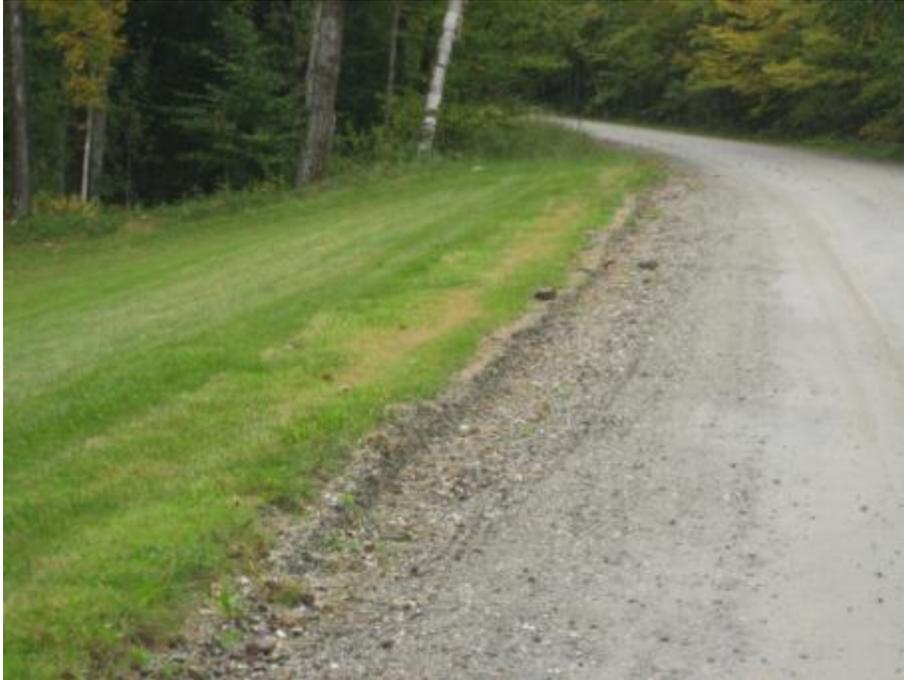
Typical on many roads is a flattening of the road surface leaving a ridge of material that directs the flow of water into the road.

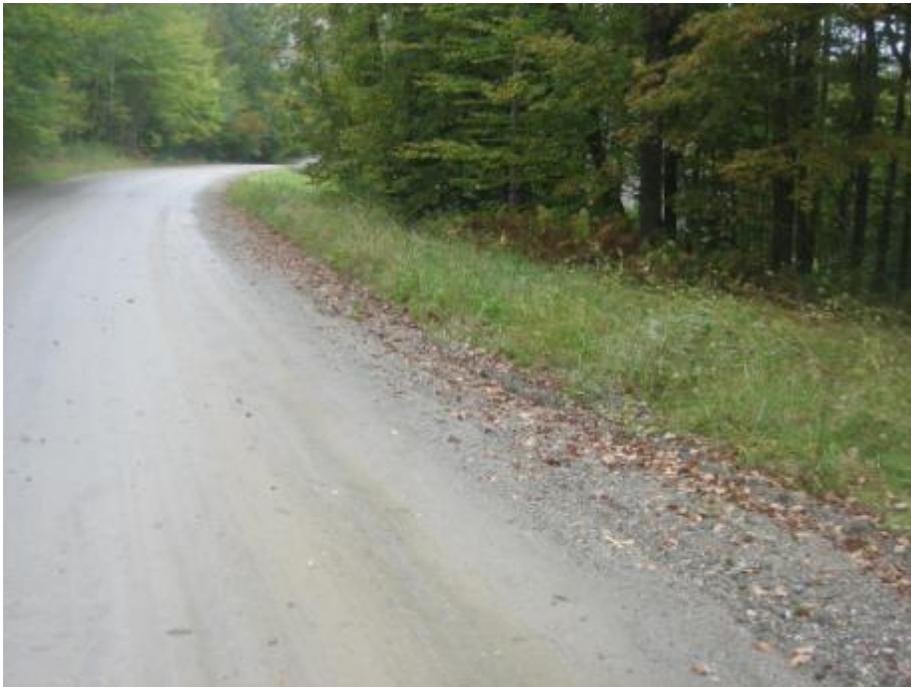
Similar to above photo.

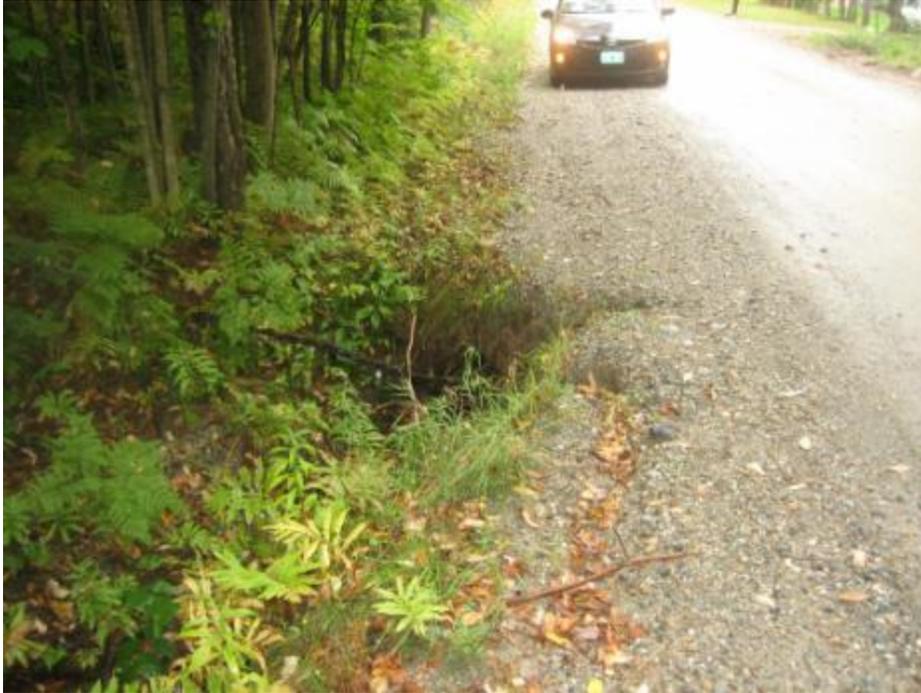
Where severe erosion occurs at culvert outlets, increase the length of the pipe. Improve inlet and outlet by reshaping and stone lining. (Carse Road)

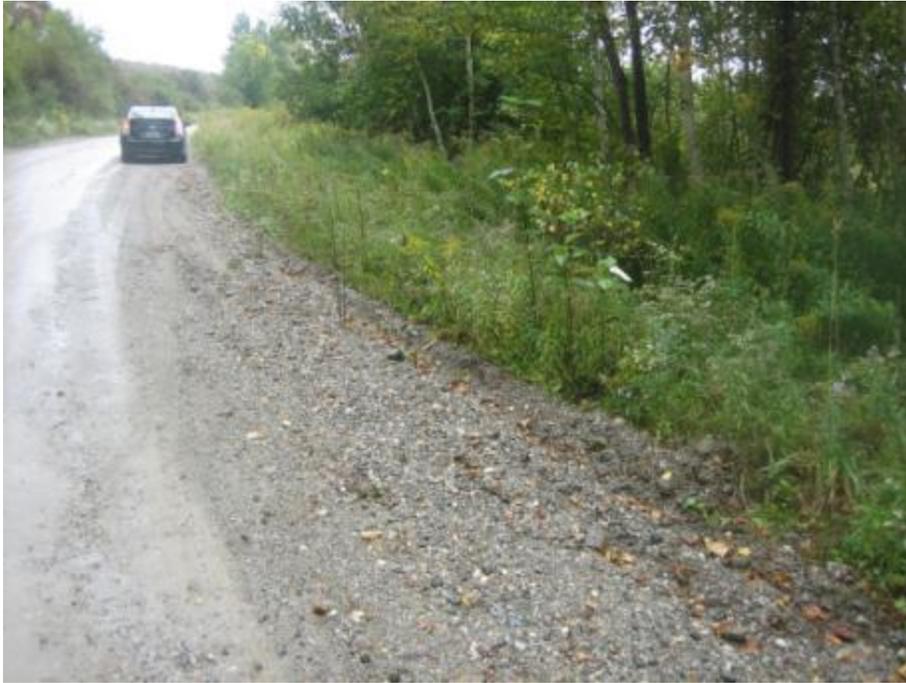
Gravel is carried away because of berm, no ditch. (Upper Carse Road)

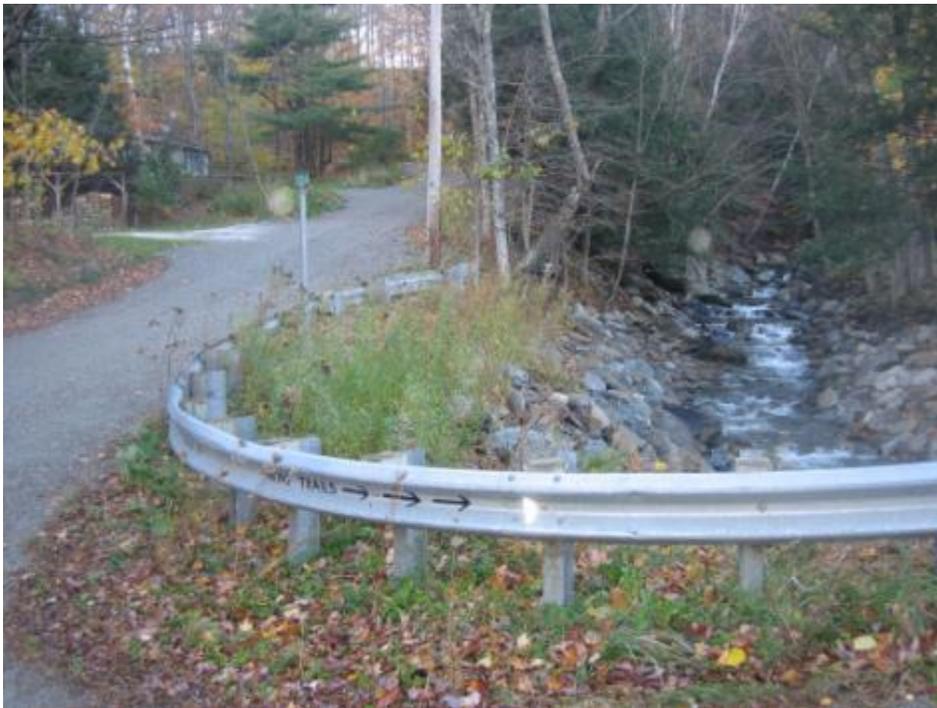
Many roads lie close to streams such as Fielder Road at Camels Hump Road.

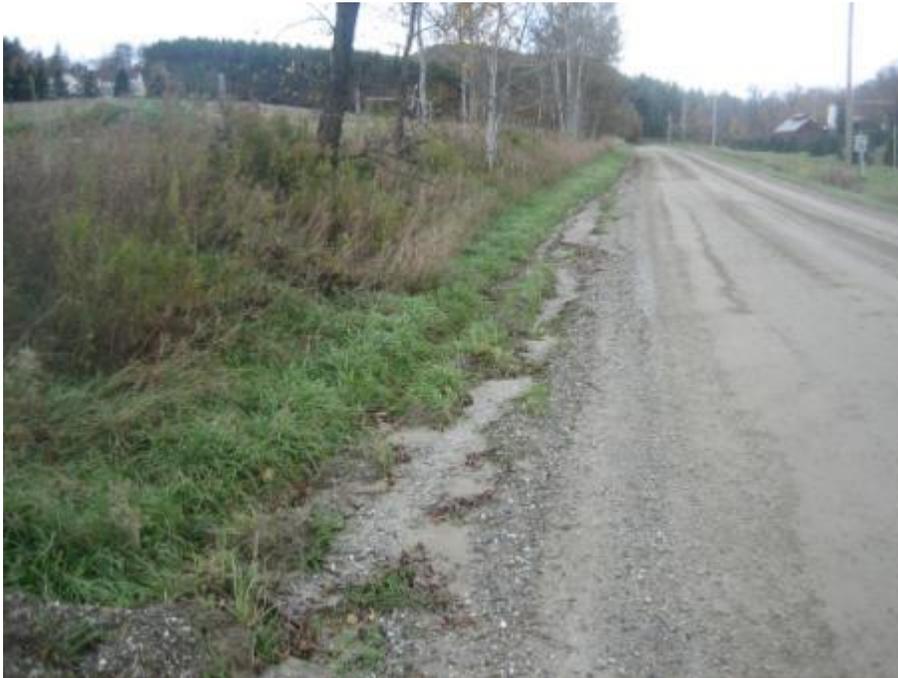
Same point looking uphill on Pond Road. Both sides require ditch maintenance but north side is more severe. Note lack of road crown.

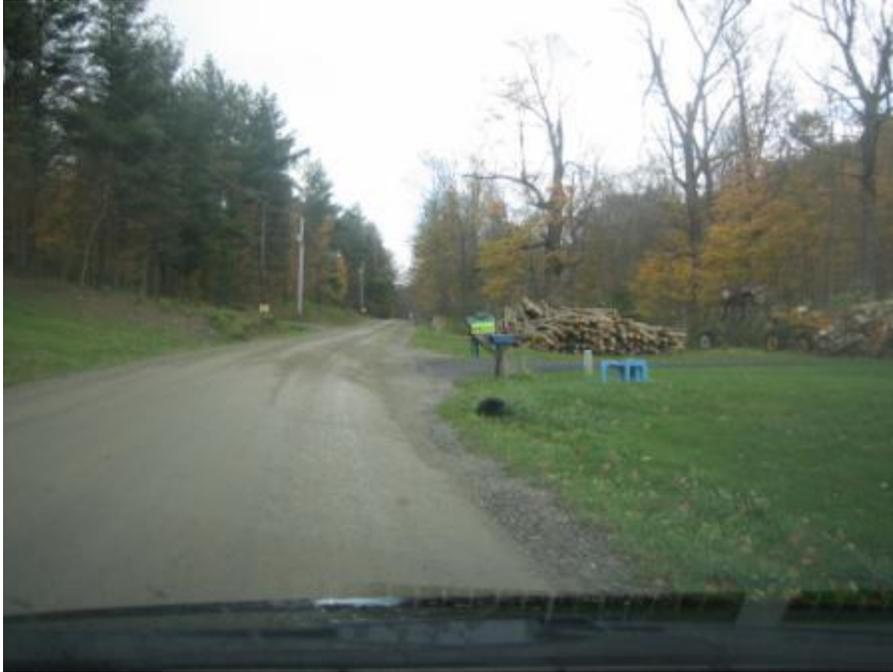
Culvert pipe at Mailbox #190 is askew and does not receive water. Note washing.

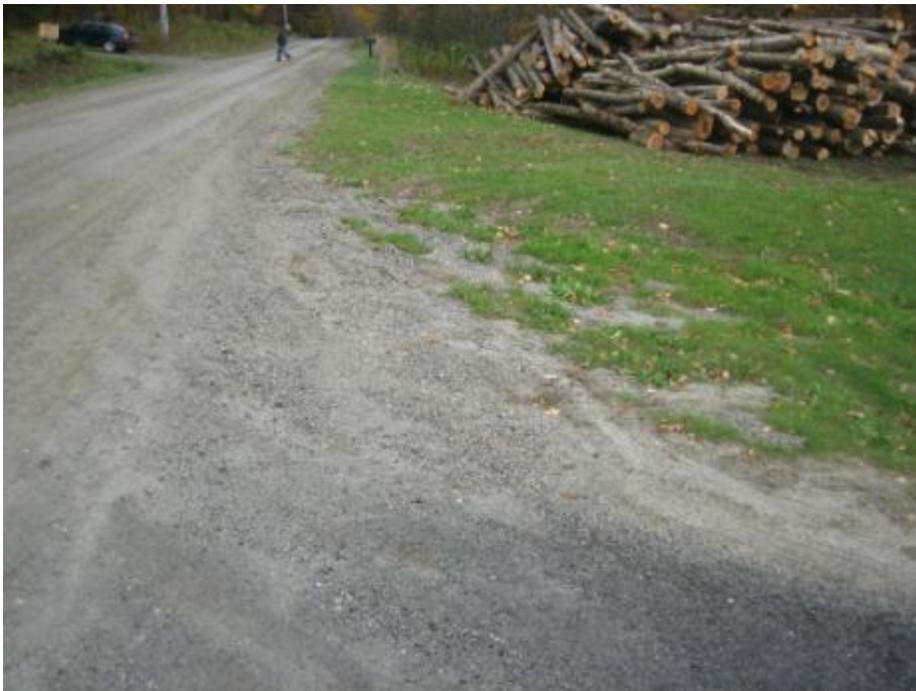
Misdirected water above the driveway culvert inlet at mailbox #190 on Pond Road.

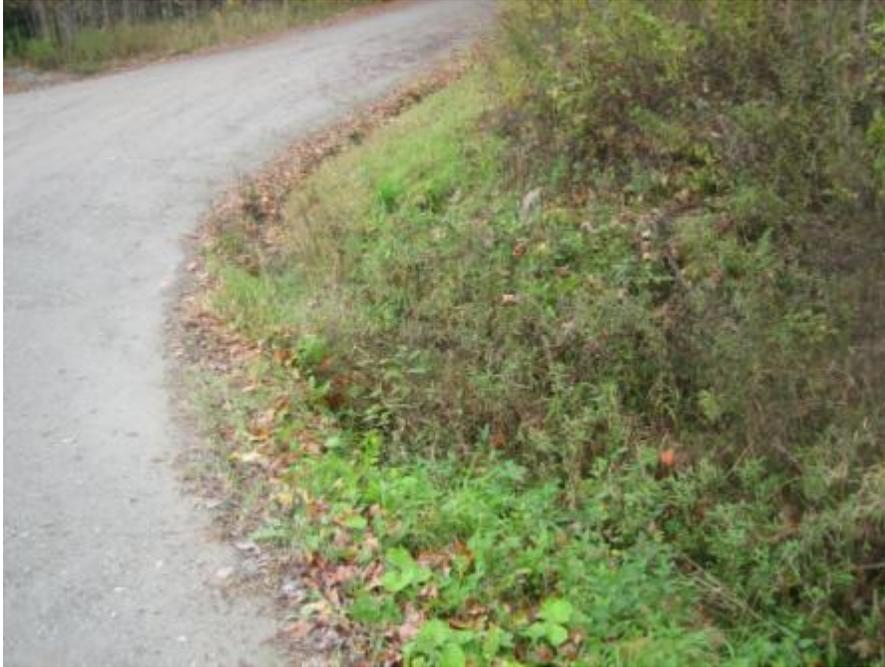
At road junctures like this, insure that water is directed by adequate stone-lined ditches. (Happy Hollow Road looking up from Pond Road)

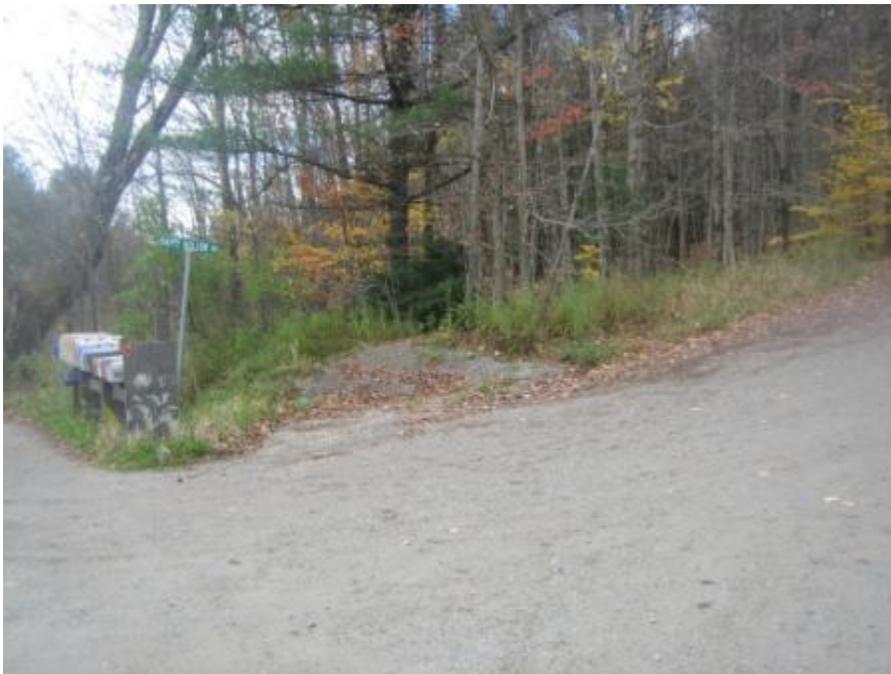
Note accumulation of gravel that has washed down the road and stockpiled.

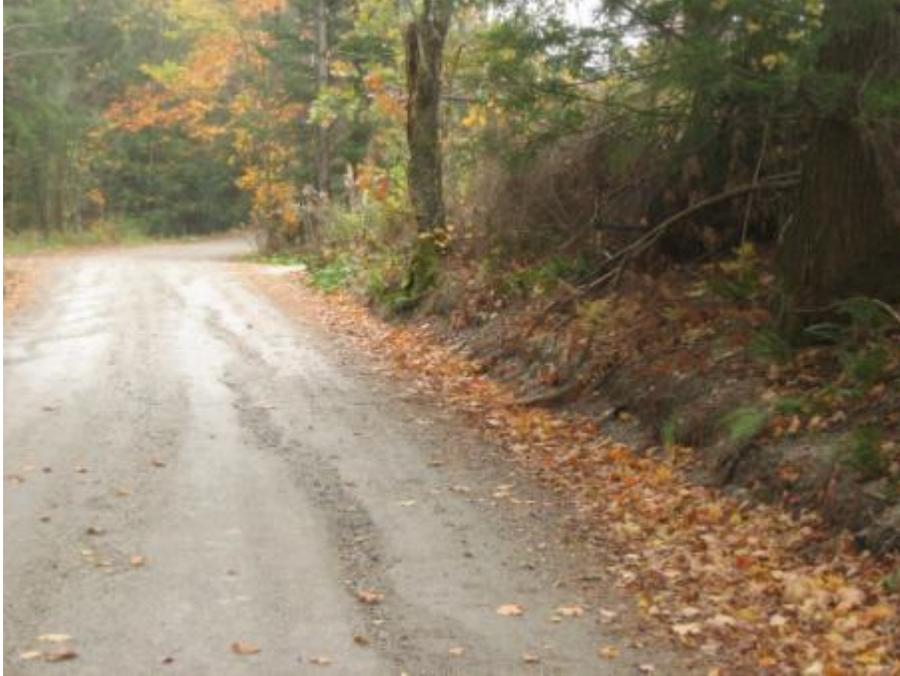
Tree on right is an obstruction to plowing and to creating a roadside ditch. Consider 1 or 2 cross culverts in this area. (Happy Hollow Road)

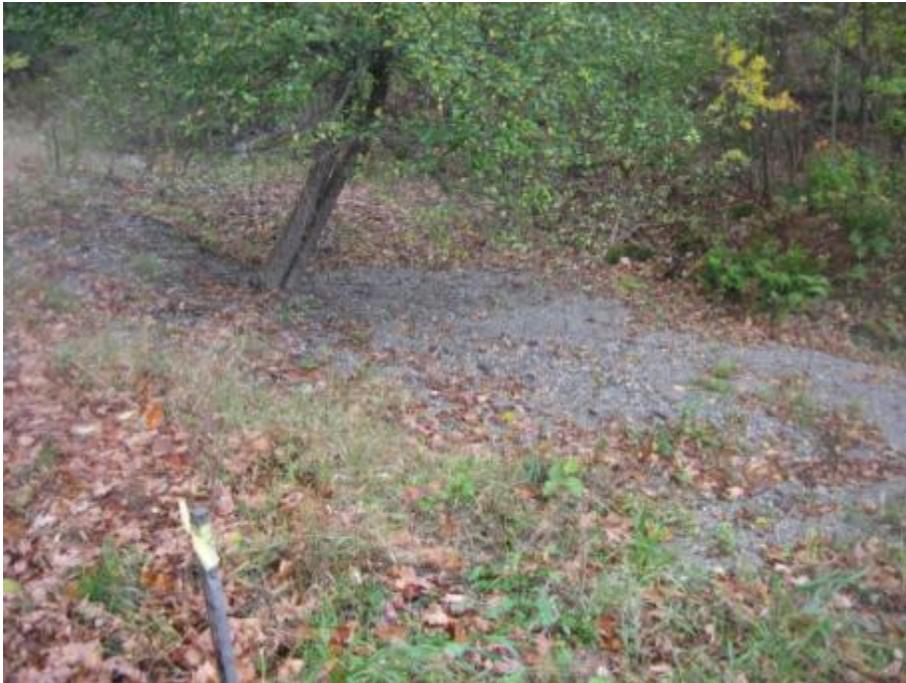
Gravel lost to the roadside. No ditch. (Happy Hollow Road, below Mail box #557)

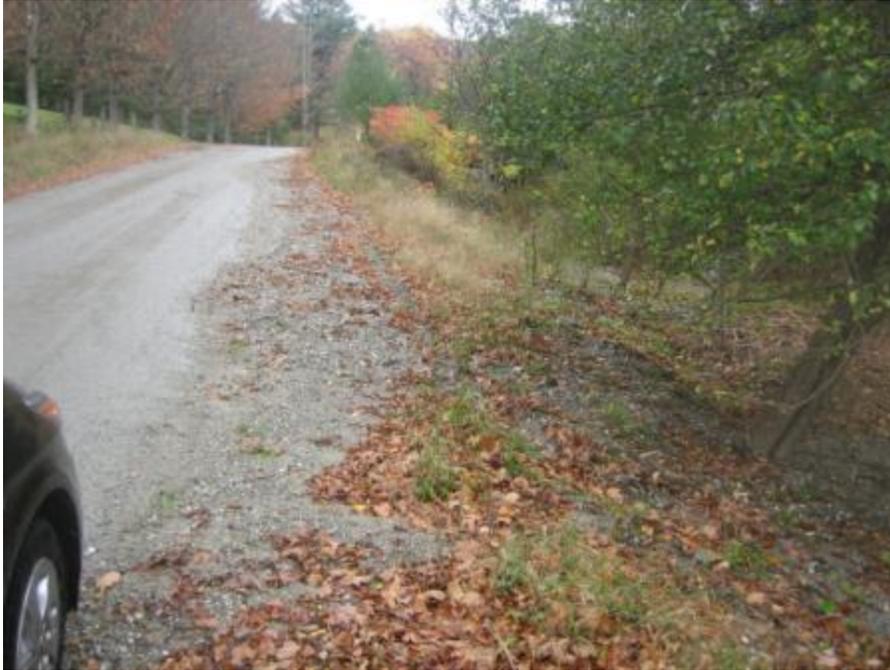
Evidence of water traveling down the road and over the shoulder. (Happy Hollow Road)

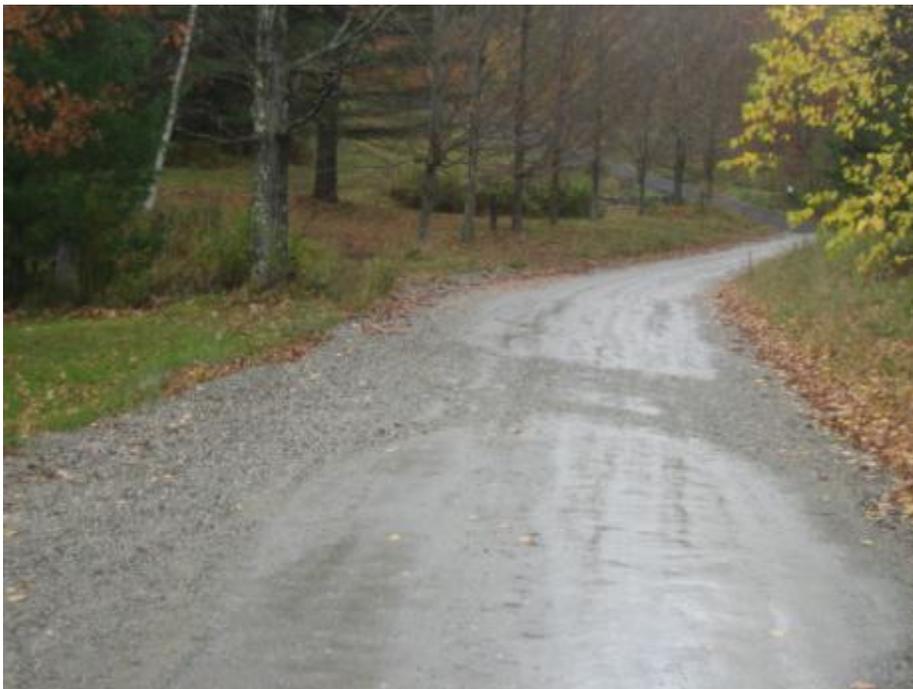
Severe washing for about 1,500 feet. (Kier Road)

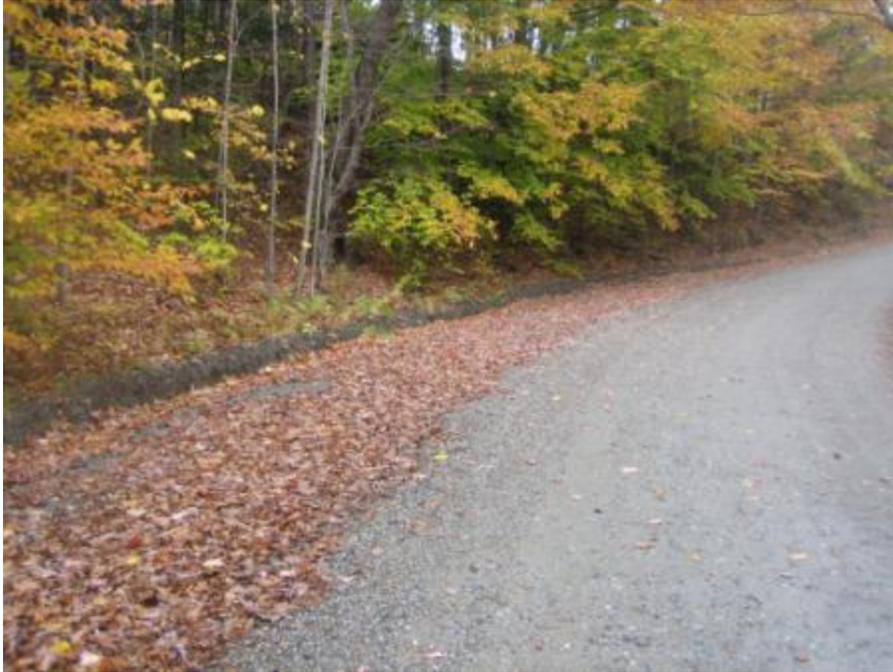
Typical for most of the distance of Kier Road.

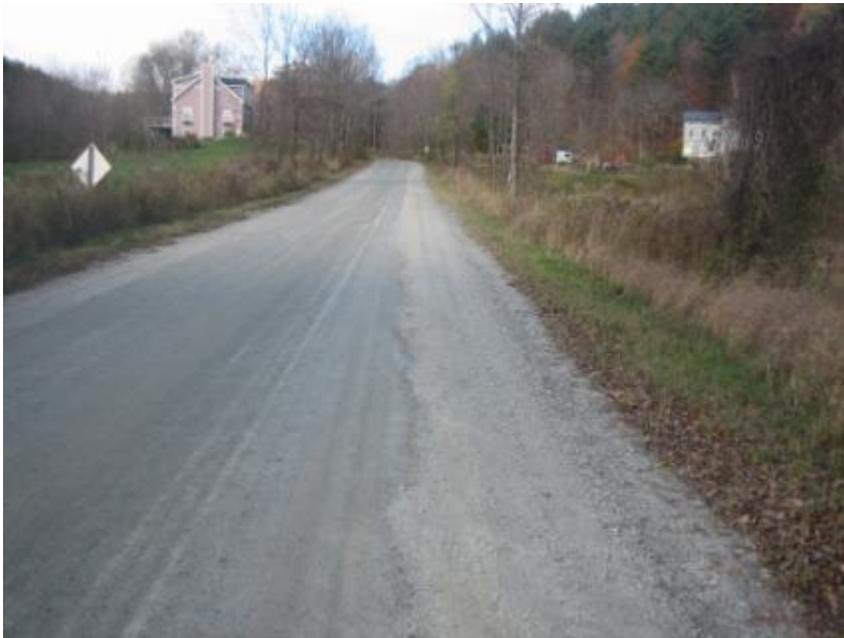
Almost the entire length of Salvas Road requires ditching and stone lining. About 12 turnouts need improvement.

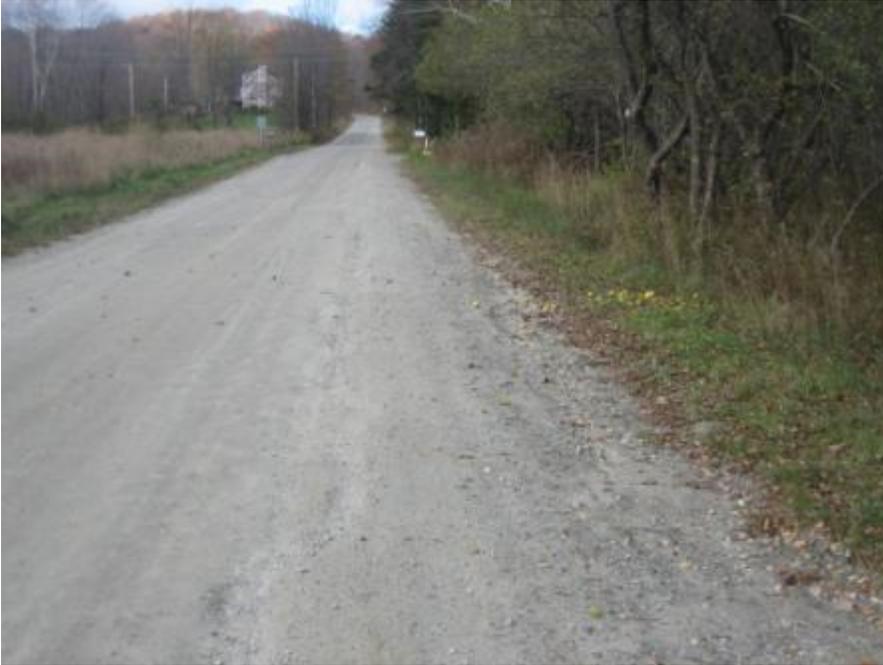
Typical lack of ditches, flat surface, washing and deposits of gravel on roadside. (Salvas Road)

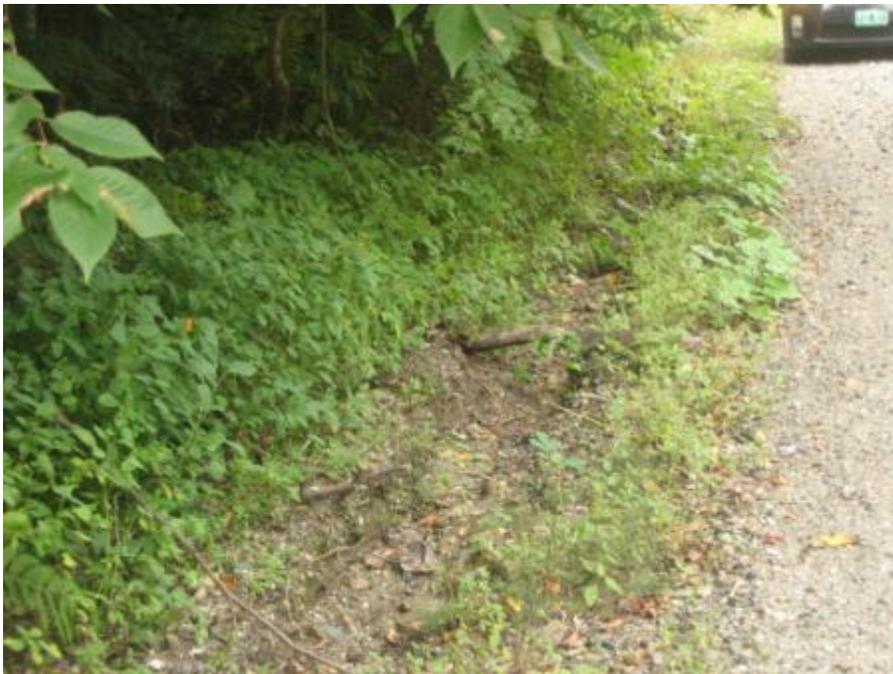
Gravel, muck and debris in ditch (Weaver Road)

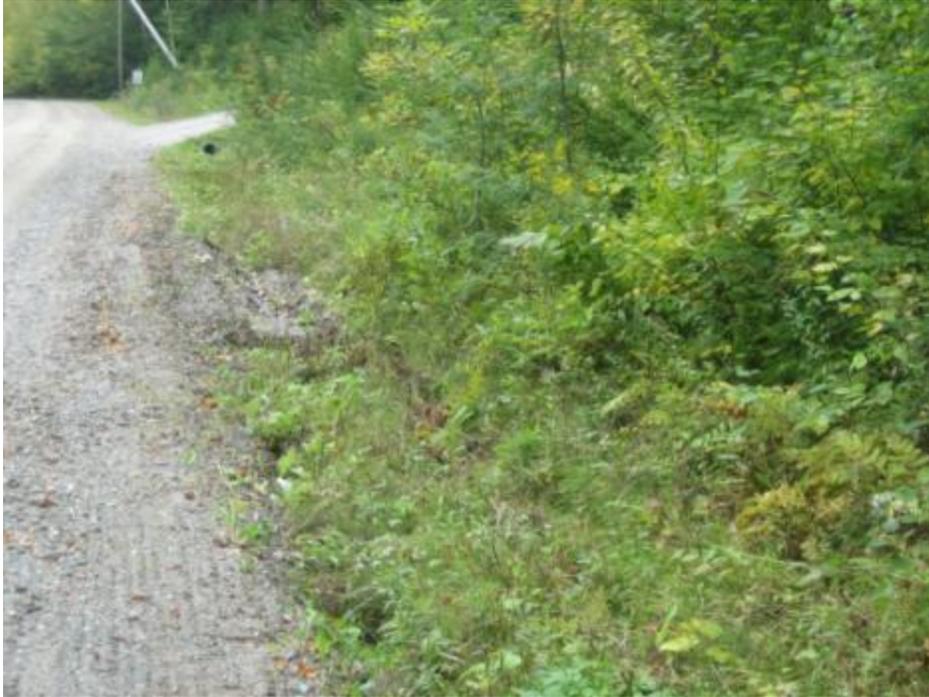
Severe erosion. Ditch is filled in and is no longer capable of diverting water. (Weaver Road)

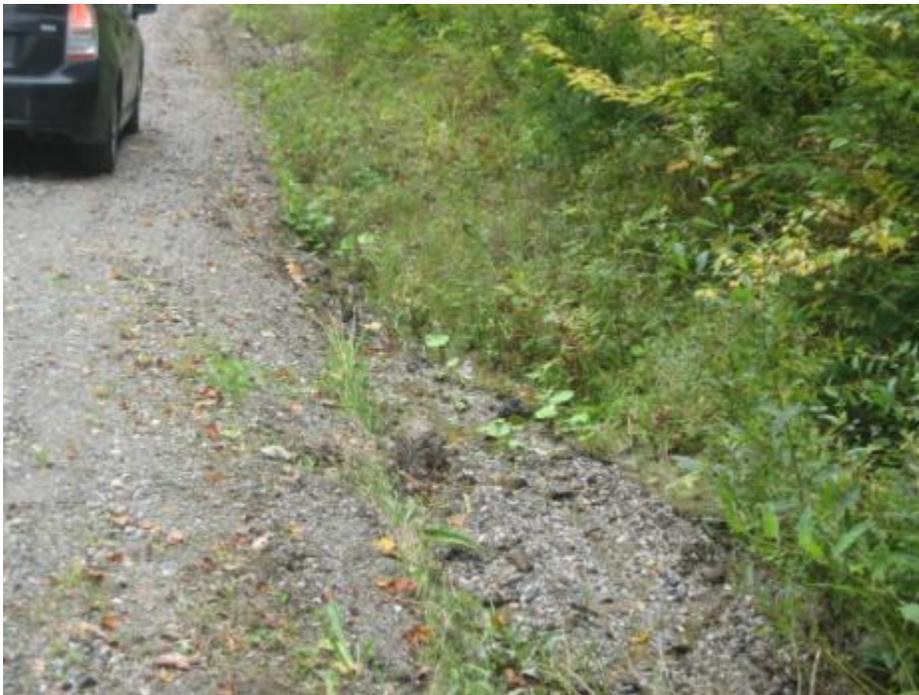
Accumulation of gravel in ditch line. (Weaver Road)

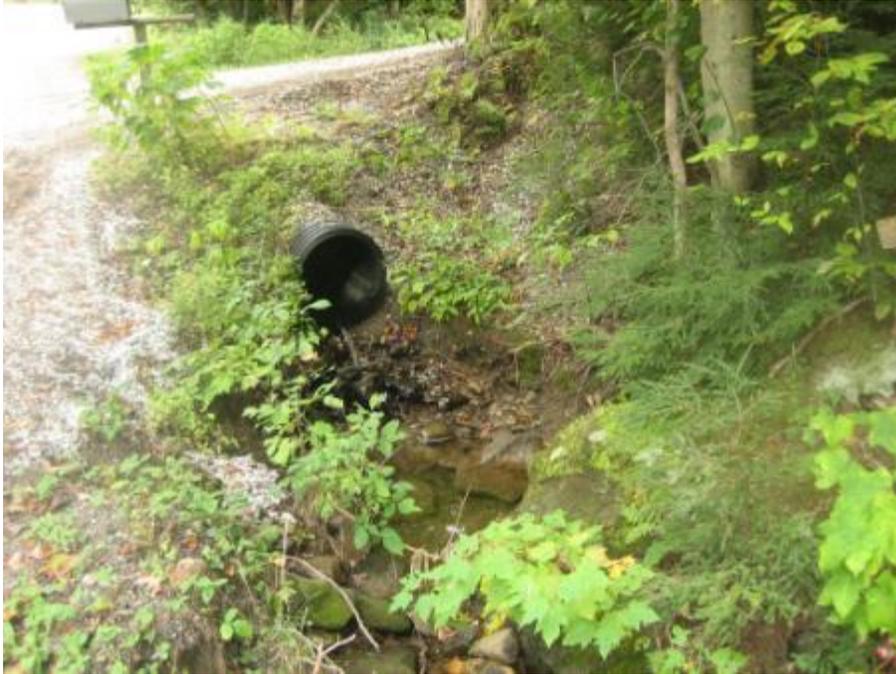
Severe erosion at driveway culvert outlet at Mail Box # 682 (Weaver Road)

Condition Severe to Fair
Notes Ditching needed for entire length.
 Varied conditions: Severe erosion in spots; roadside berms; poor ditches
 Severe erosion at inlet and outlet of driveway culvert at mailbox # 682
Remedies At bottom for 1,000' create shallow ditches with periodic turnouts.
 From mailbox # 350 downhill on south side (400'), create ditch and stone line
 At mailbox # 535, downhill on south side, ditching and stone lining
 Talk with property owner at #535 to ditch and armor driveway to road
 At mailbox # 682, reshape inlet/outlet areas; considerable stone armor (300')
 North side, from # 682 to # 720 (600'), ditching and stone line
 Both sides to #900 (750'), ditching and stone lining
 From #867 to end (1,000'), ditch both sides; apply biodegradable matting

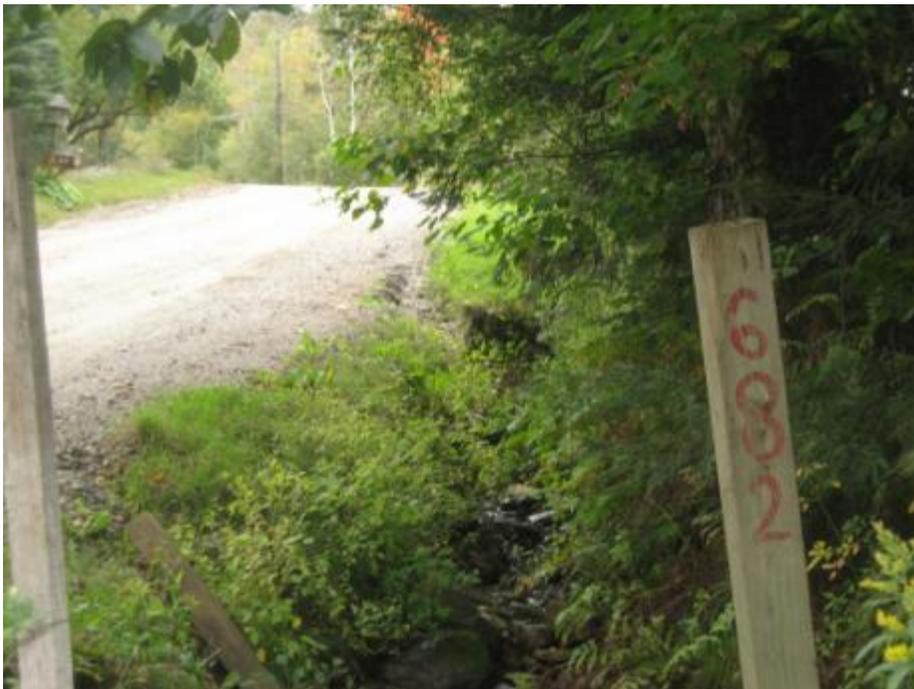
Severe erosion at driveway culvert inlet at Mail Box # 682 (Weaver Road).

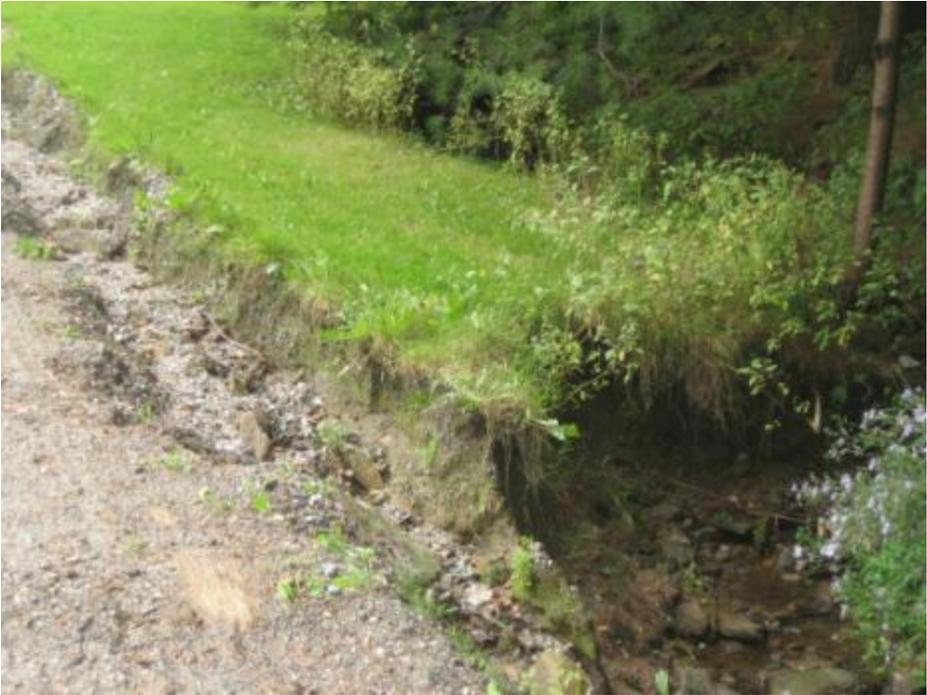
Severe erosion, north side of Weaver Road just downhill from Mail Box 867.
