Huntington BRO 1445(35)

Scoping Report

Bridge #30

Town Highway 22

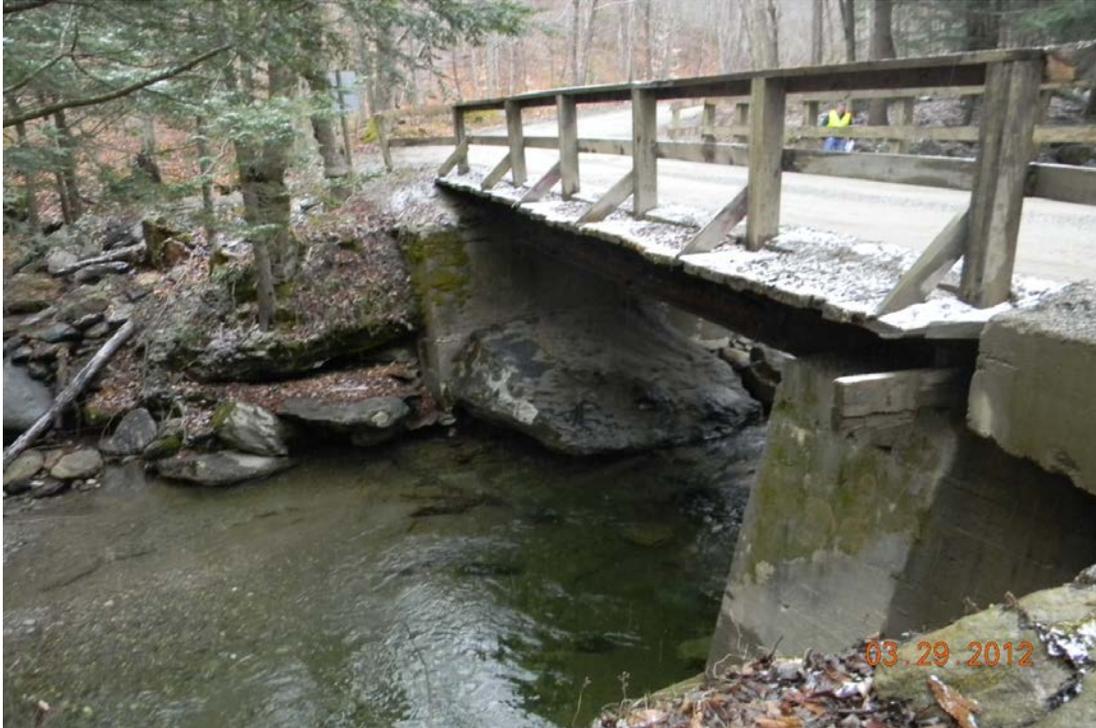
Bridge 30, looking north

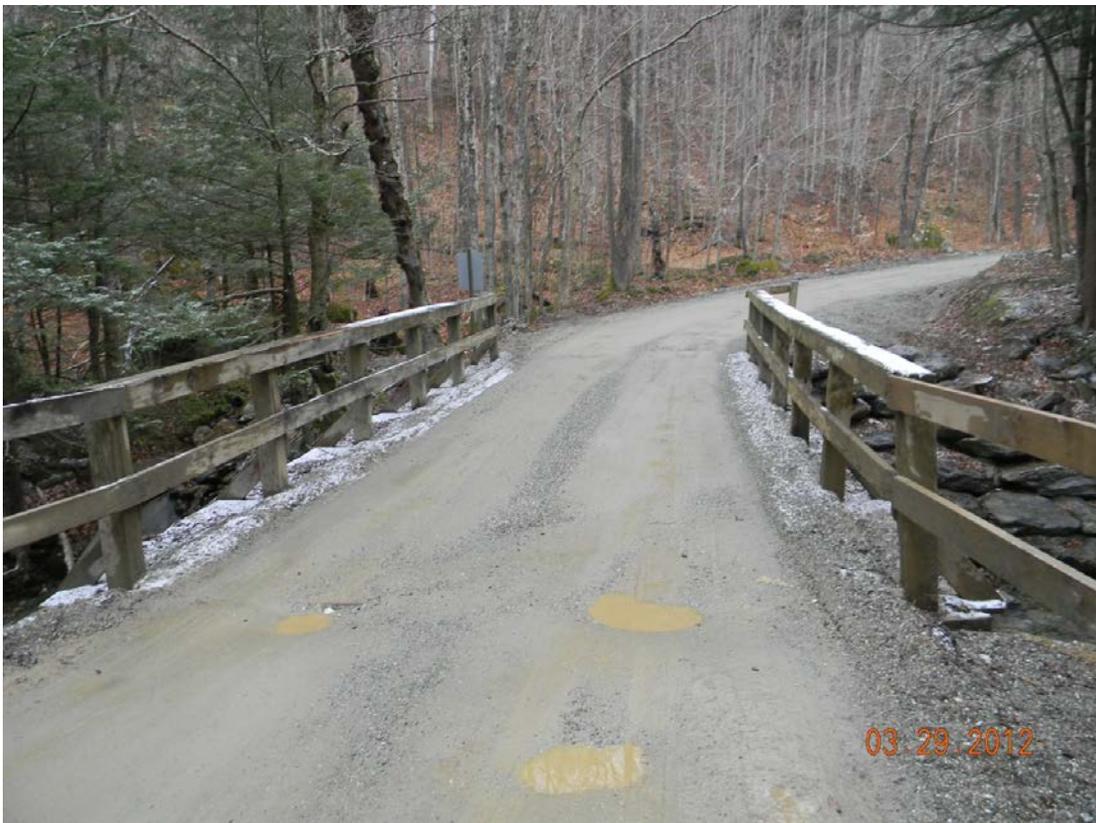
Bridge 30, looking north

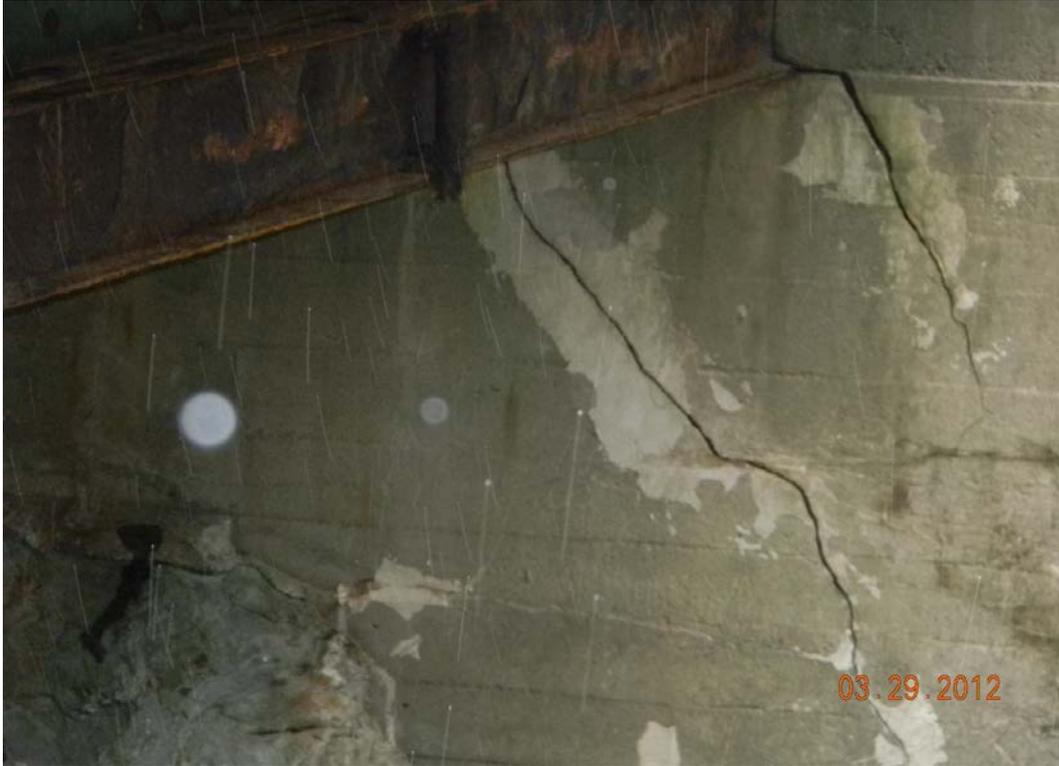
Bridge 30, north abutment – note large cracks and boulder cast into abutment at lower left corner. At top, see deteriorating steel beams

The existing structure is a timber deck on rolled steel beams. No original plans have been found, but the substructure consists of concrete abutments on shallow spread footings. There is evidence of scour at the abutments and the inspectors have noted that settlement has occurred in the past. The curb to curb width is 12.5 ft curb to curb, which is substandard. The deck is in need of replacement. The bridge is posted for 16,000 lbs.

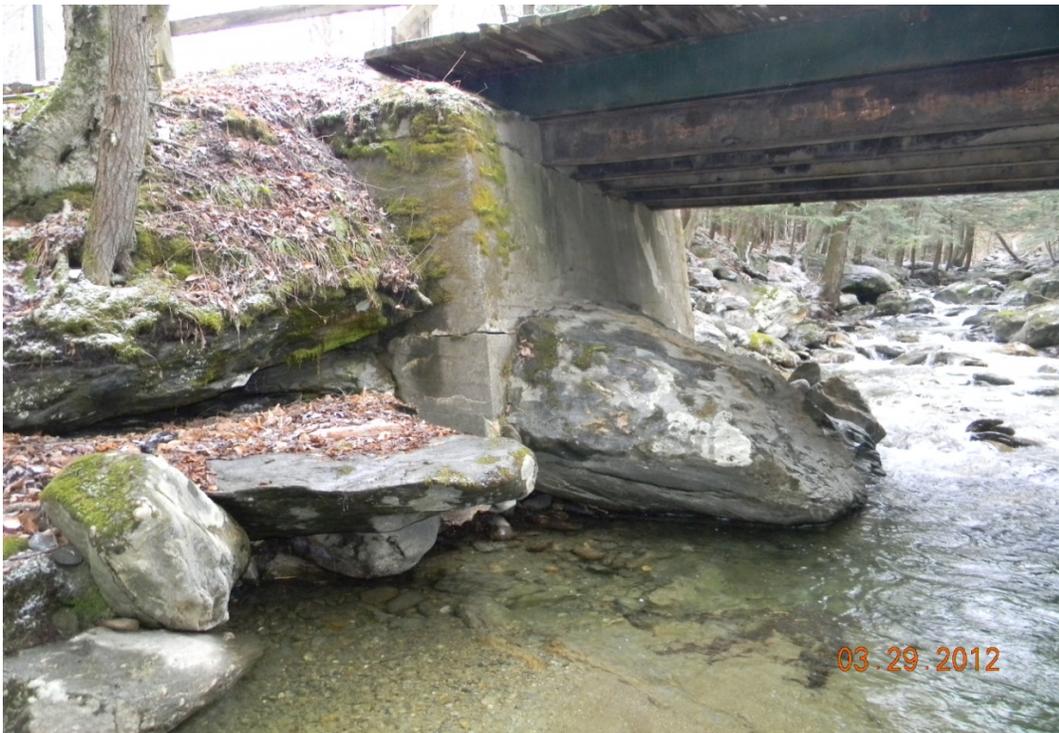
Evidence of scour, north abutment

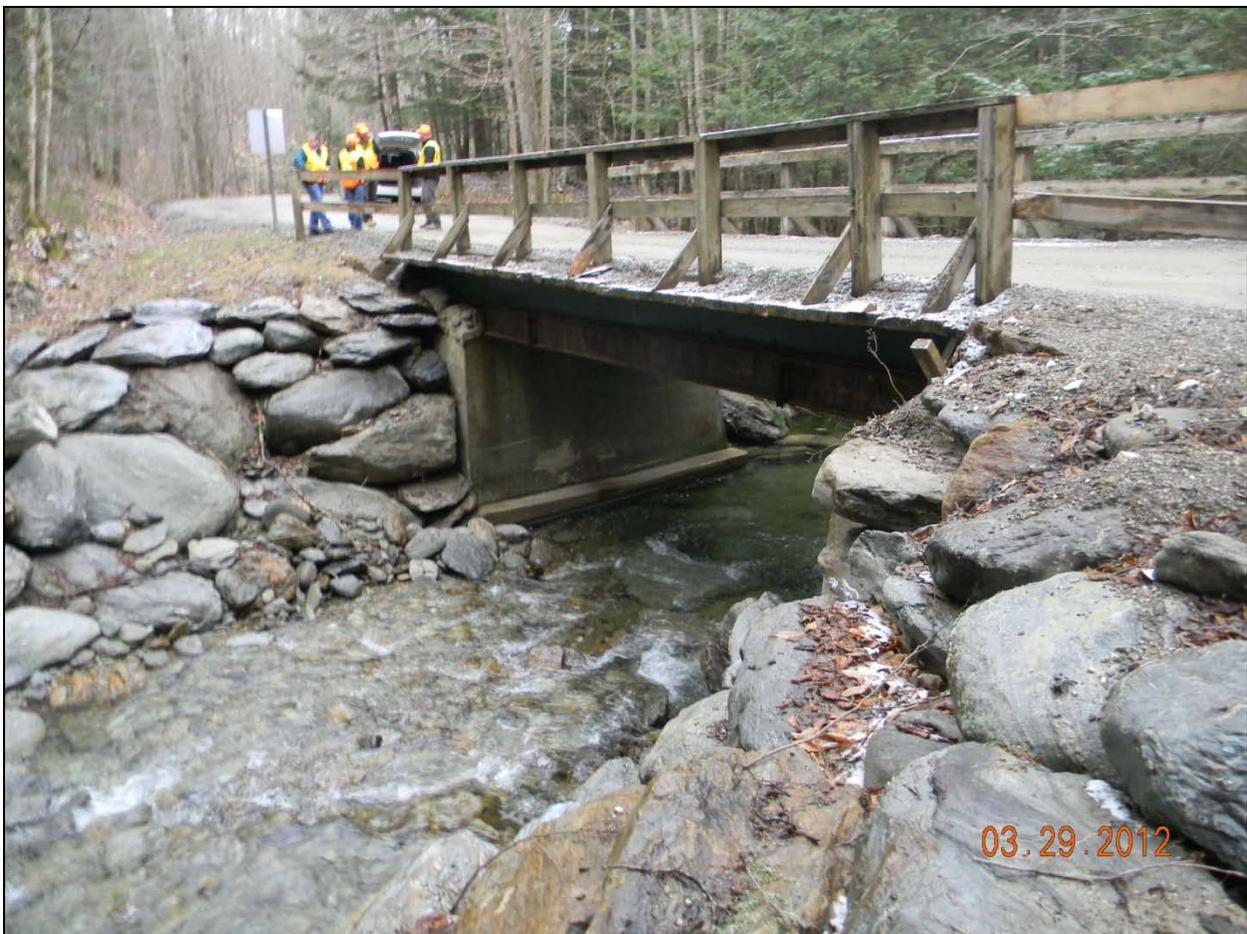
Figure 1 Photograph of subject bridge taken during Structures field visit.

In an effort to assist the Structures Section with their bridge type study, the Soils and Foundations Unit within the Materials and Research Section has completed a review of available geological data near Bridge No. 30 on Town Highway 22 which crosses over Brush Brook in Huntington, Vermont. Figure 1 shows the bridge and surrounding area.

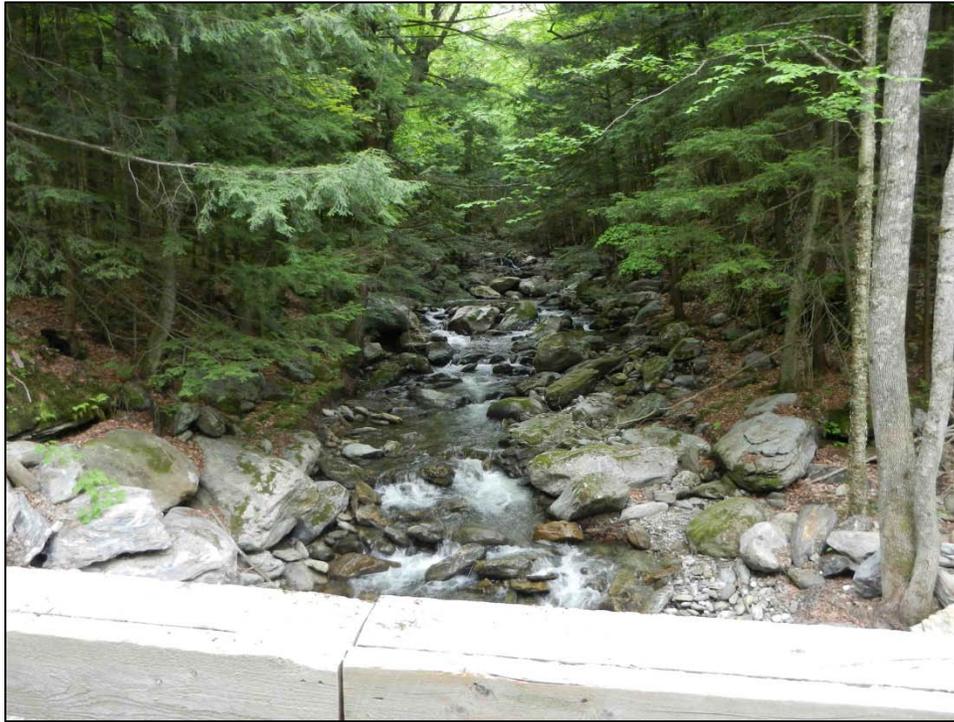
Figure 3 Photograph showing cobble to large boulder sized glacial deposits.

Surficial mapping conducted for the 1970 Surficial Geologic Map of Vermont indicates that the subject area is underlain by glacial till. Glacial till is generally very dense and may contain varying amounts of gravel, cobbles and boulders in a silt to sandy silt matrix. A photograph

taken during the March 12, 2012 field trip (Figure 2) shows cobbles and large boulders all along the slopes adjacent to Brush Brook which flows under the subject bridge.
