Water and Wastewater Capacity: Issues and Opportunities in Huntington's Village Districts

Lower Huntington Village, Huntington Center, and Hanksville

Amy Macrellis, Alan Huizenga, & the Water & Wastewater Working Group

November 15, 2011

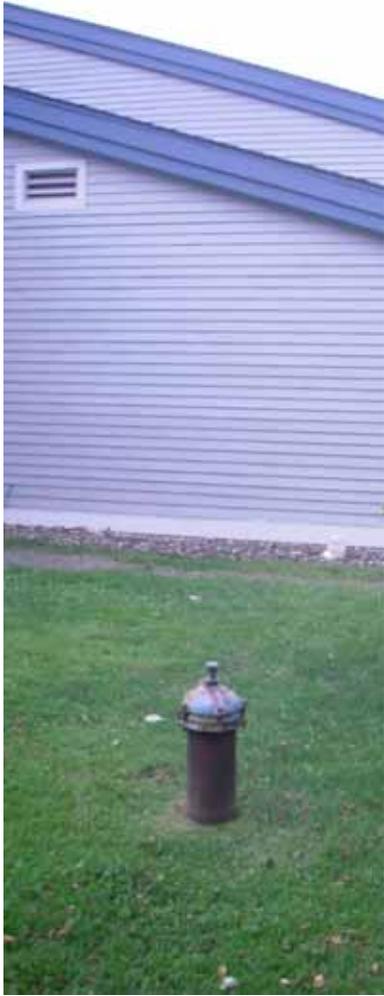
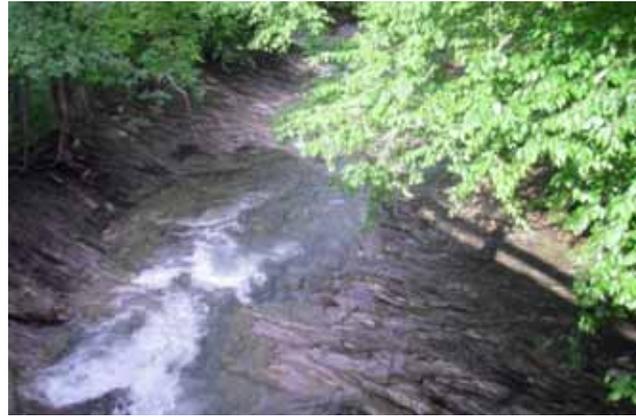
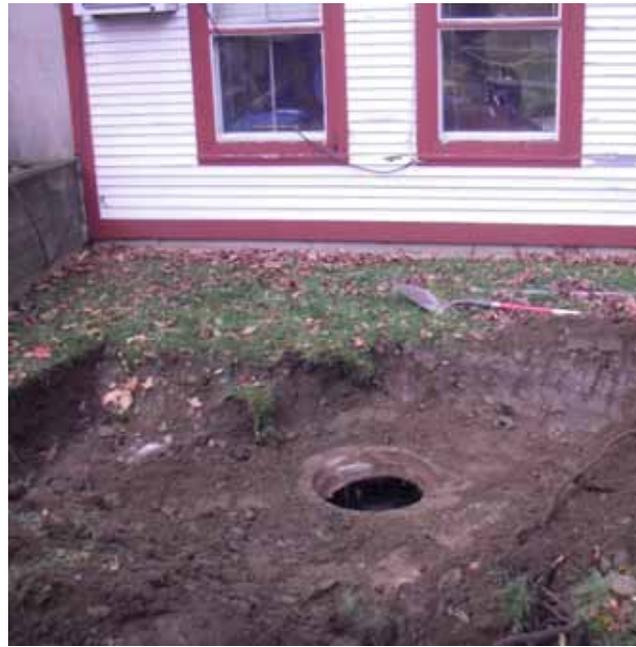
- Natural resource inventory (topography, wetlands, floodplains, streams, soils, geology)
- Infrastructure inventory (property owner surveys and site visits, permit reviews, State private well database)

Natural resources and water infrastructure in Huntington, Summer-Fall 2011.

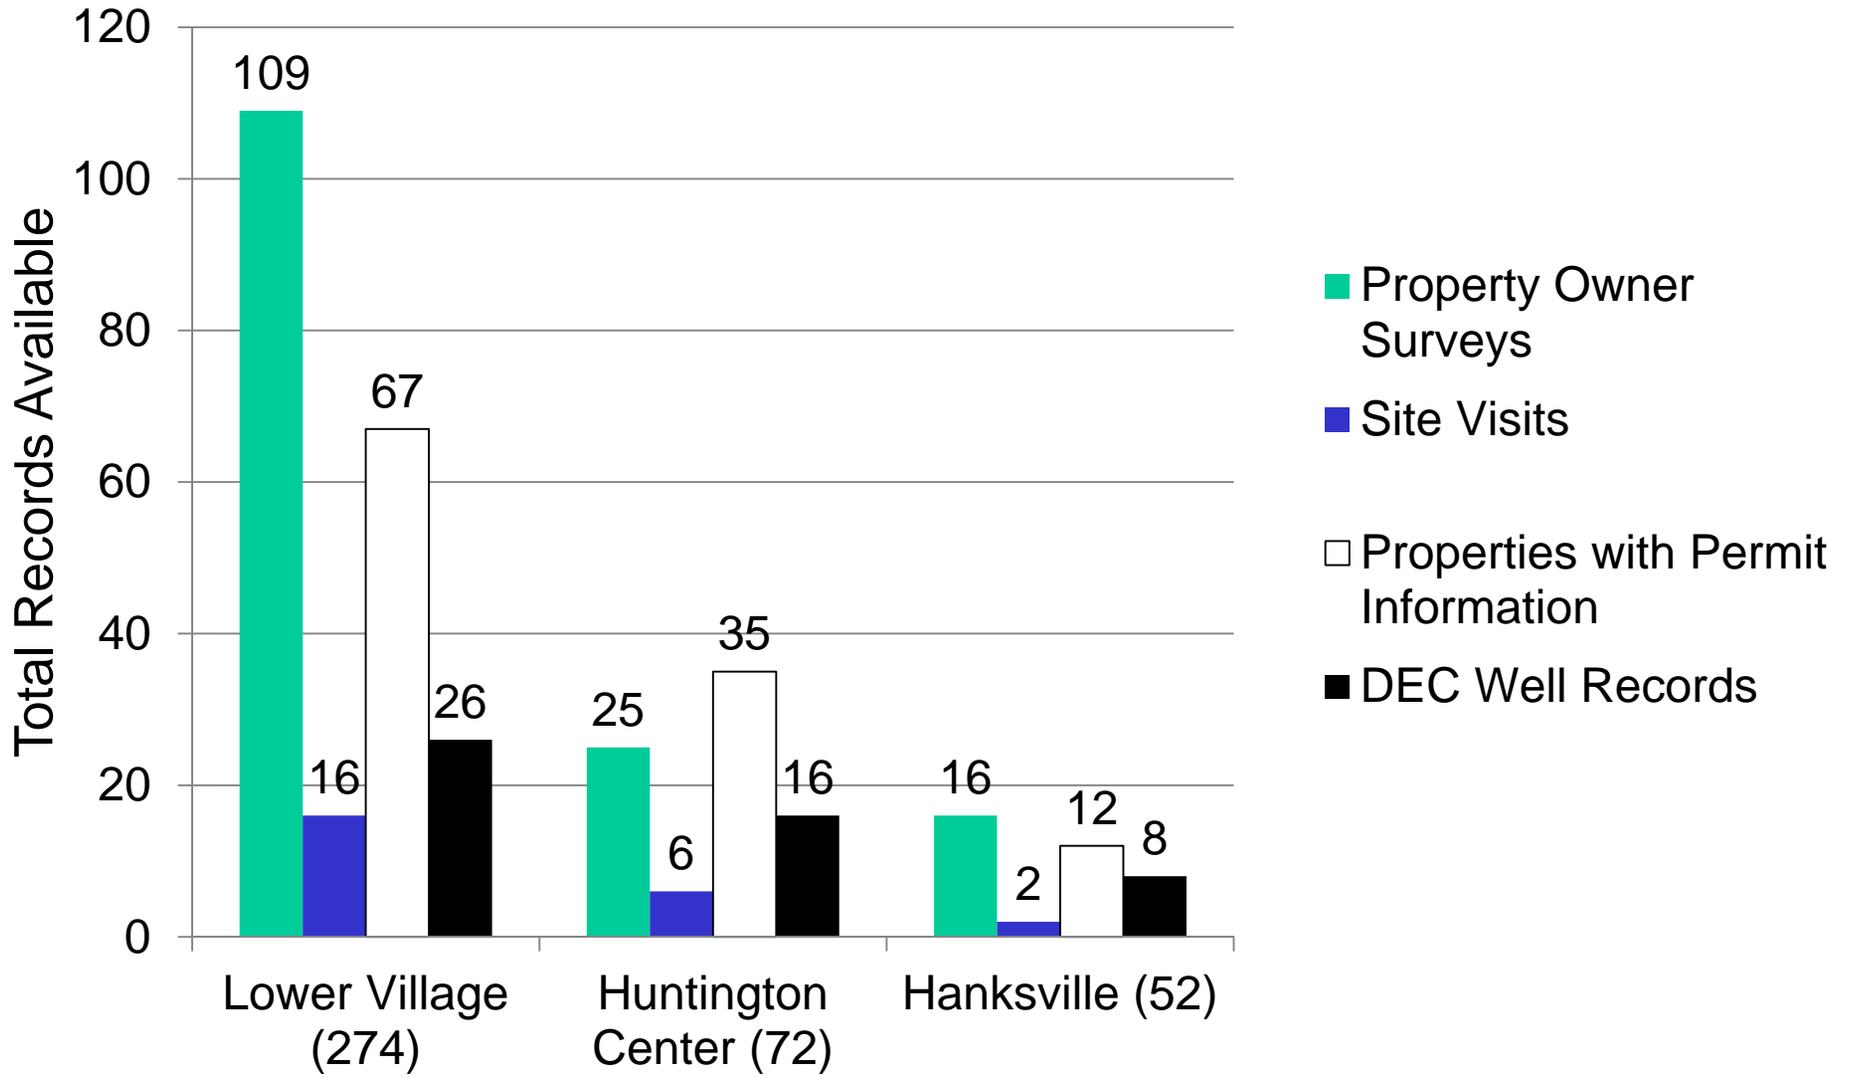
Infrastructure inventory data sources summary by village.

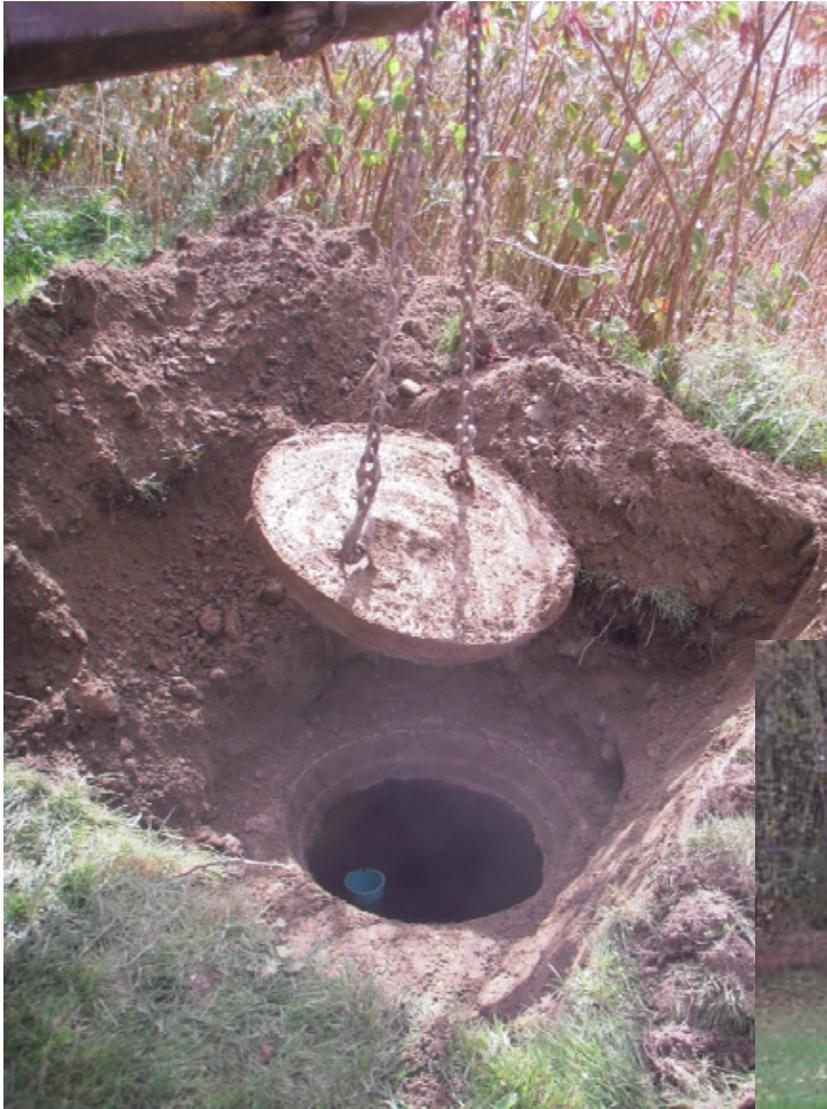
Site-Specific System Evaluations

- Completed for all Town-owned properties
 - School system in great shape
 - A few repairs needed at Town Garage, Fire Dept.
- Also completed for 18 private properties

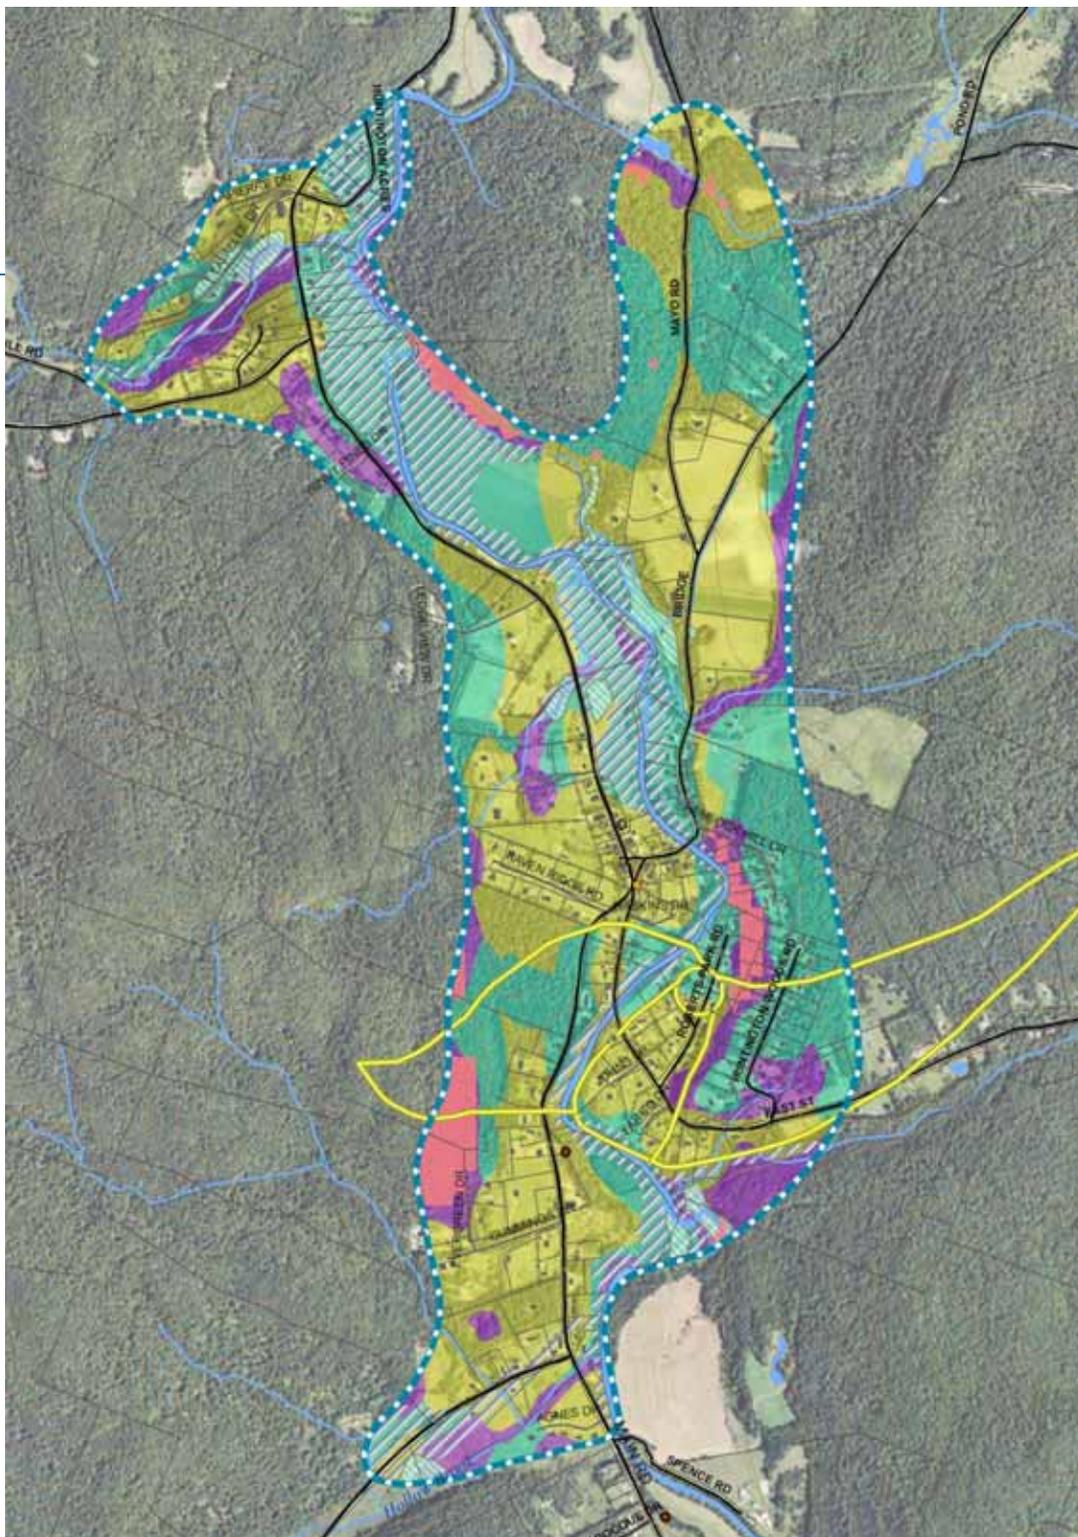
■ Lower Village

- Limited wetlands, but large area in 100-year floodplain
- ~40% of soils suitable for in-ground leachfields
- Surficial, gravel and bedrock aquifers

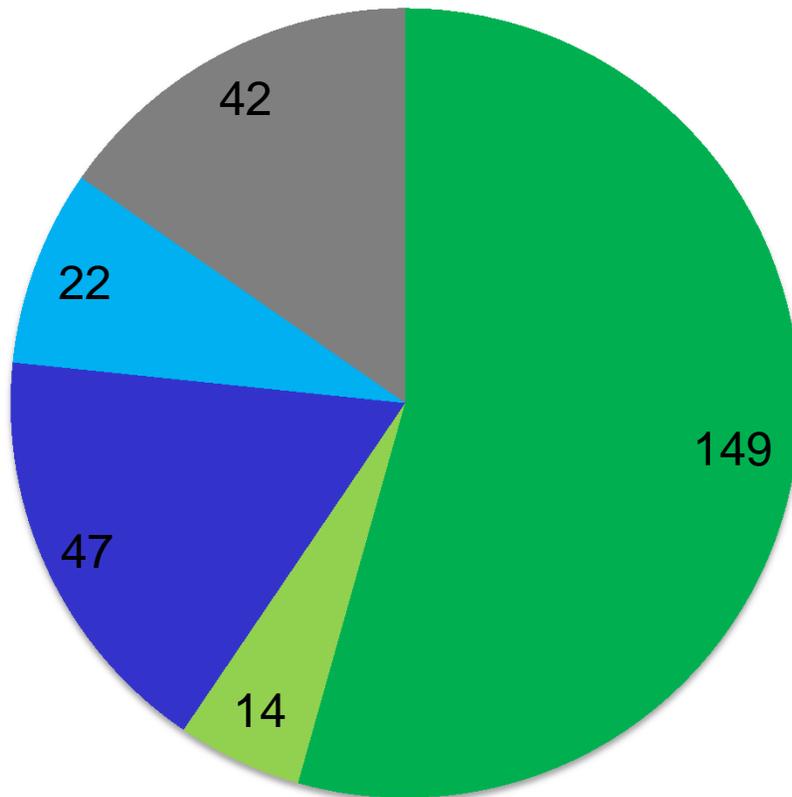
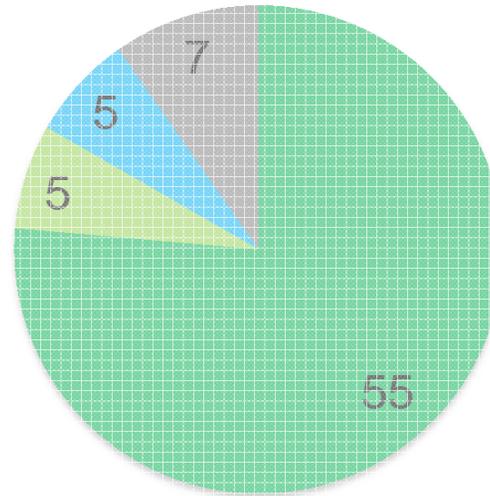
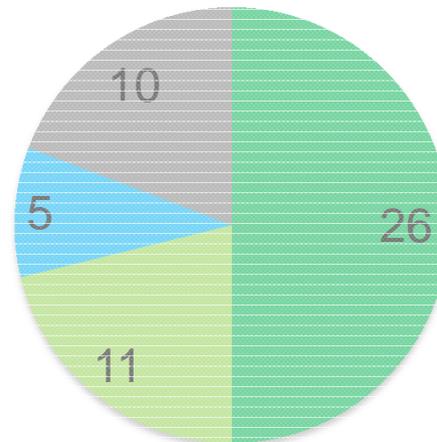
Current Water Supply Infrastructure

- Individual or shared drilled wells
- Individual or shared shallow wells/springs
- Connections to Huntington FD No. 1
- Undeveloped locations, no water
- No water supply information

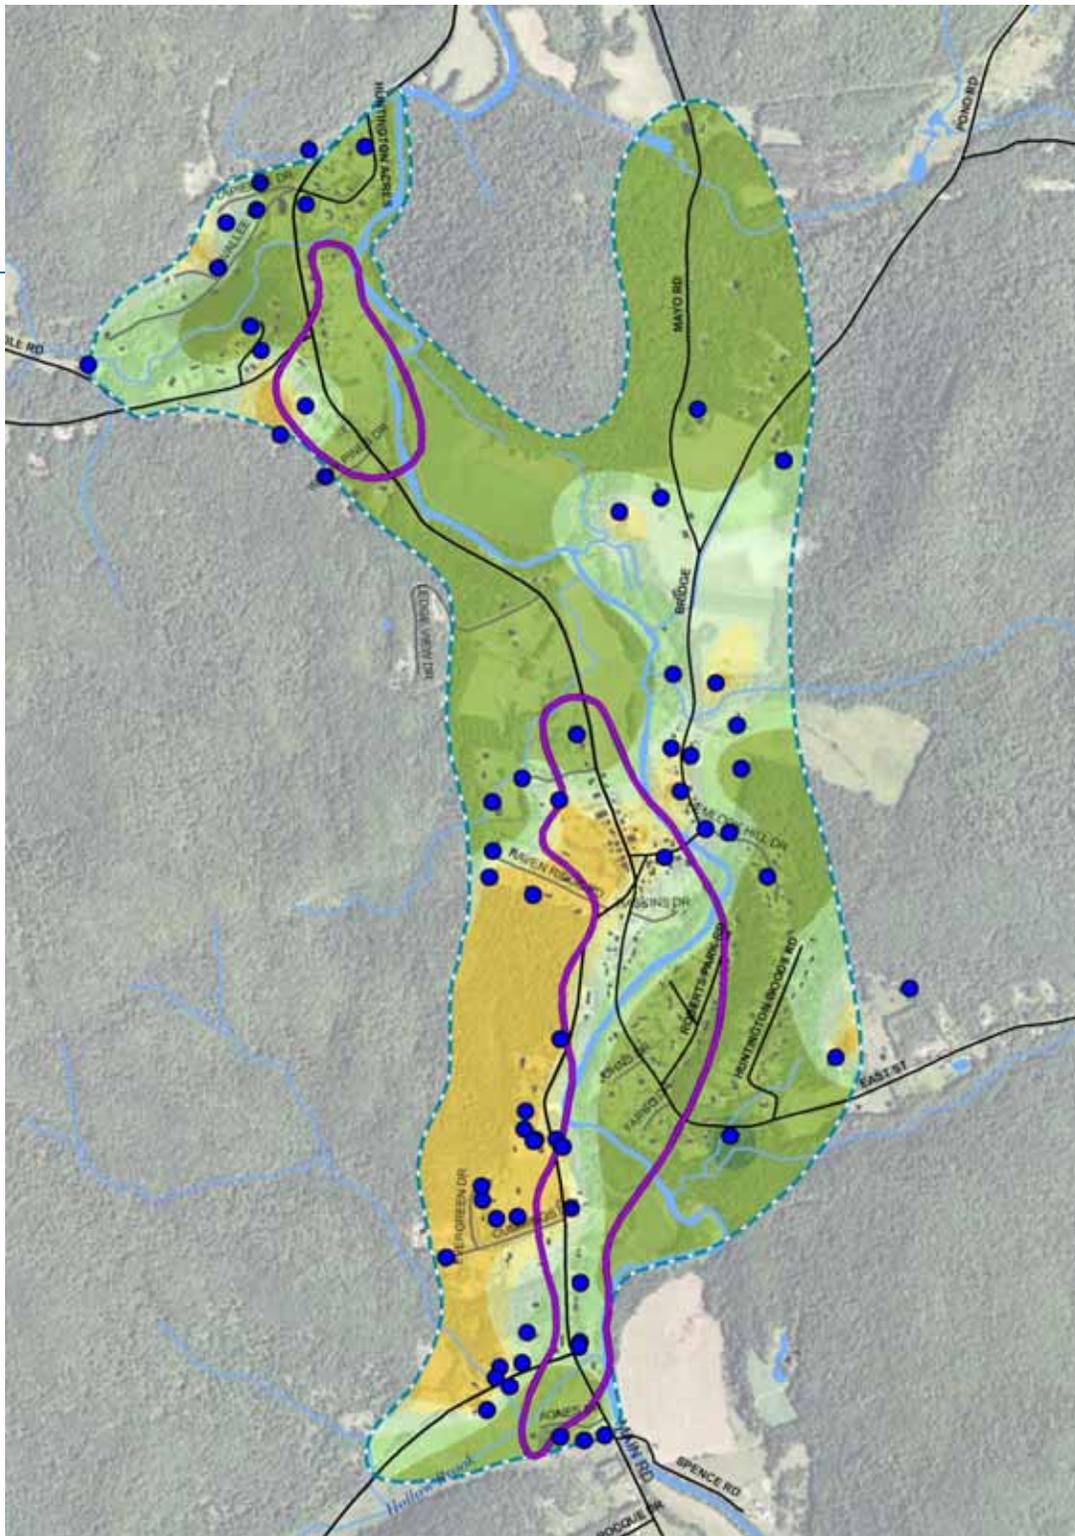
Lower Village

- Small proportion of dug wells or springs
- Drilled gravel wells are high-yielding
- Low-yielding bedrock wells in southwest portion of village
- Water quality issues include aesthetics, coliform (~17%)

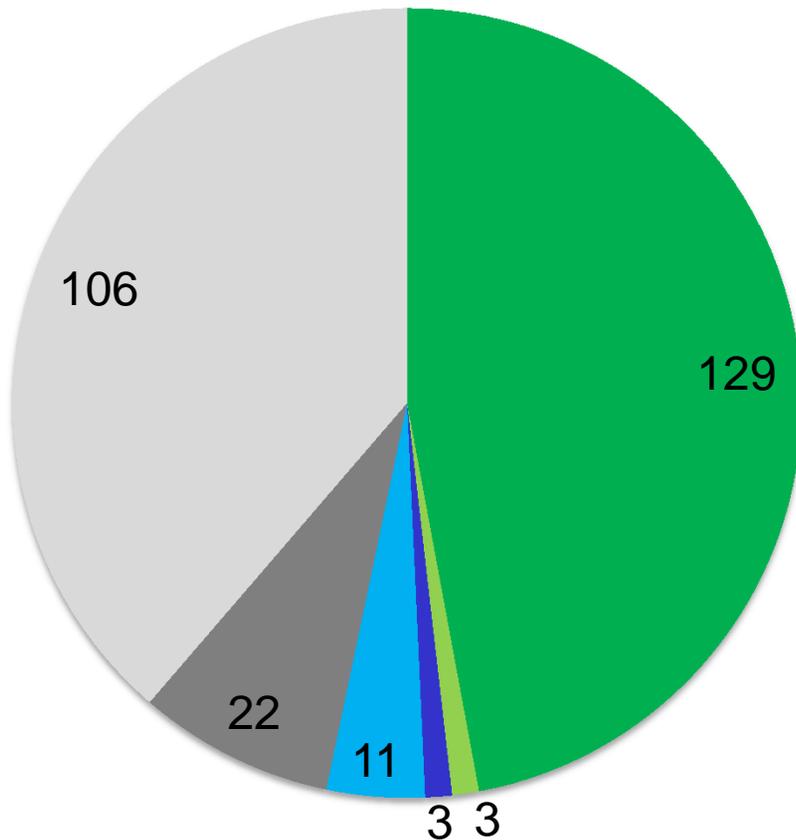
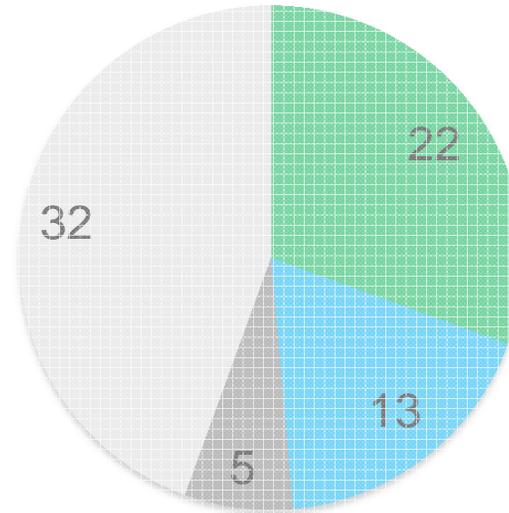
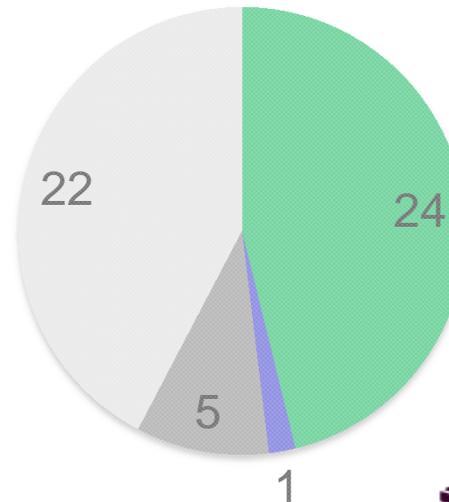
Current Wastewater Treatment Infrastructure

- In-ground septic systems
- Raised or mound systems
- Advanced treatment, best fix, etc.
- Connections to shared leachfields
- No wastewater treatment system
- No wastewater treatment information

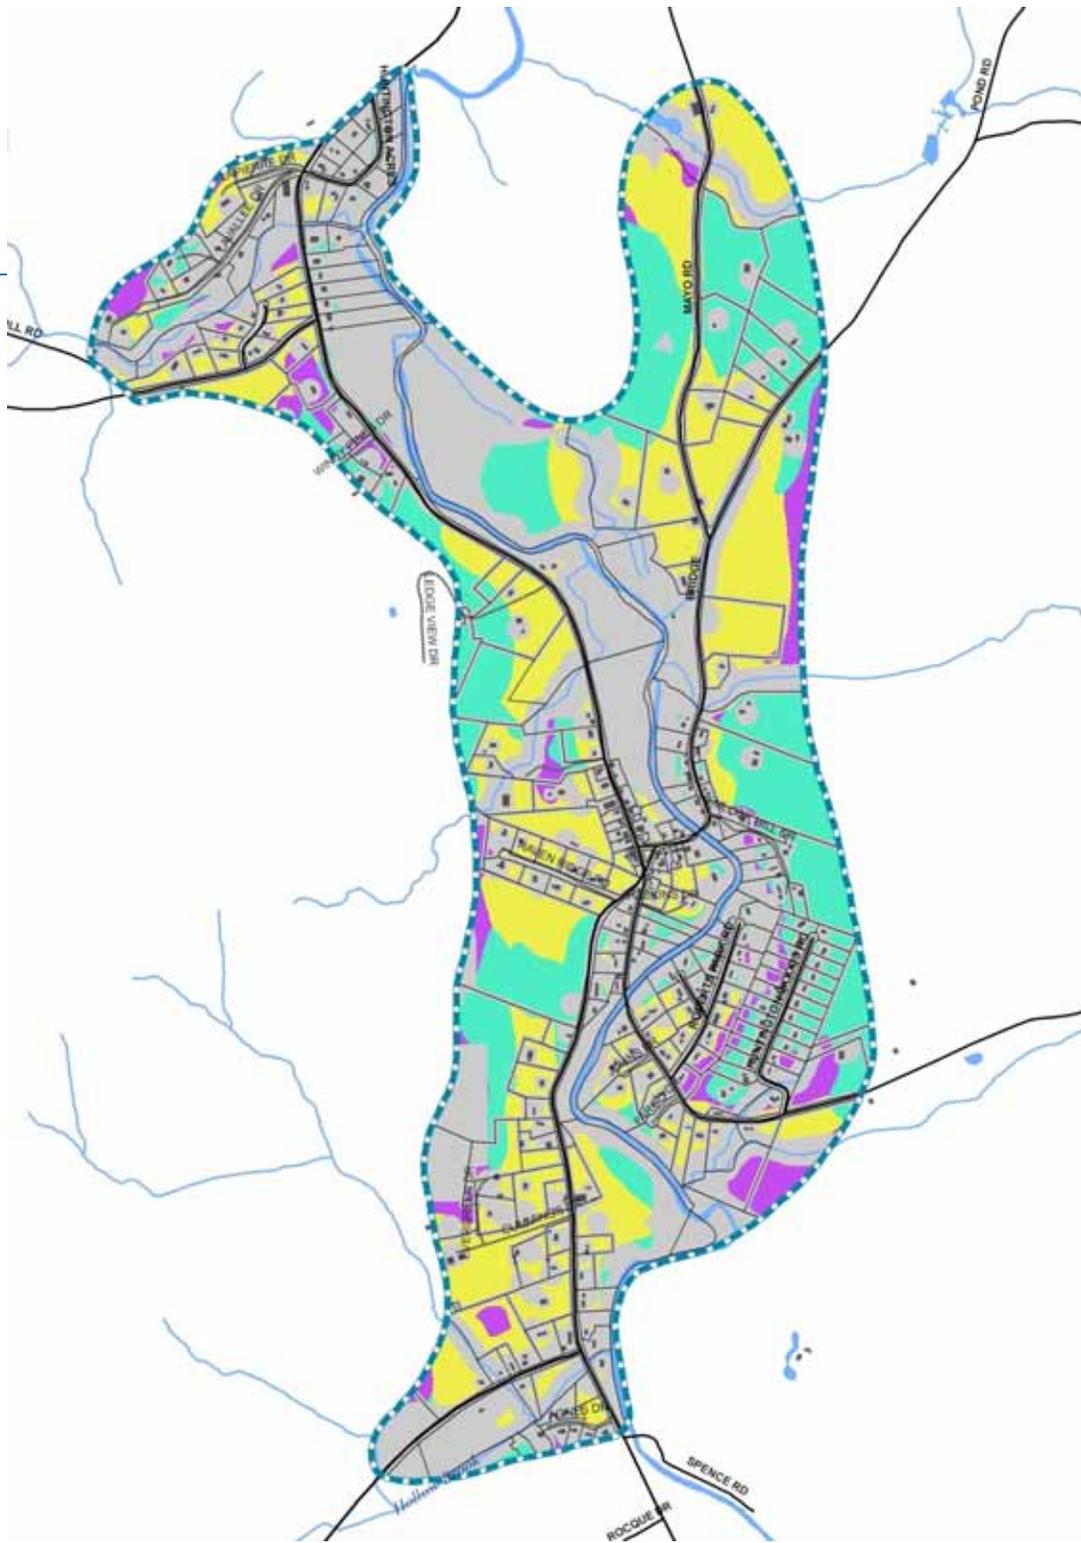
Lower Village

- Primary environmental limitations are streams, floodplains
- Well shields are primary development-related limitation, esp. on small lots
- Several instances where future plans need wastewater capacity

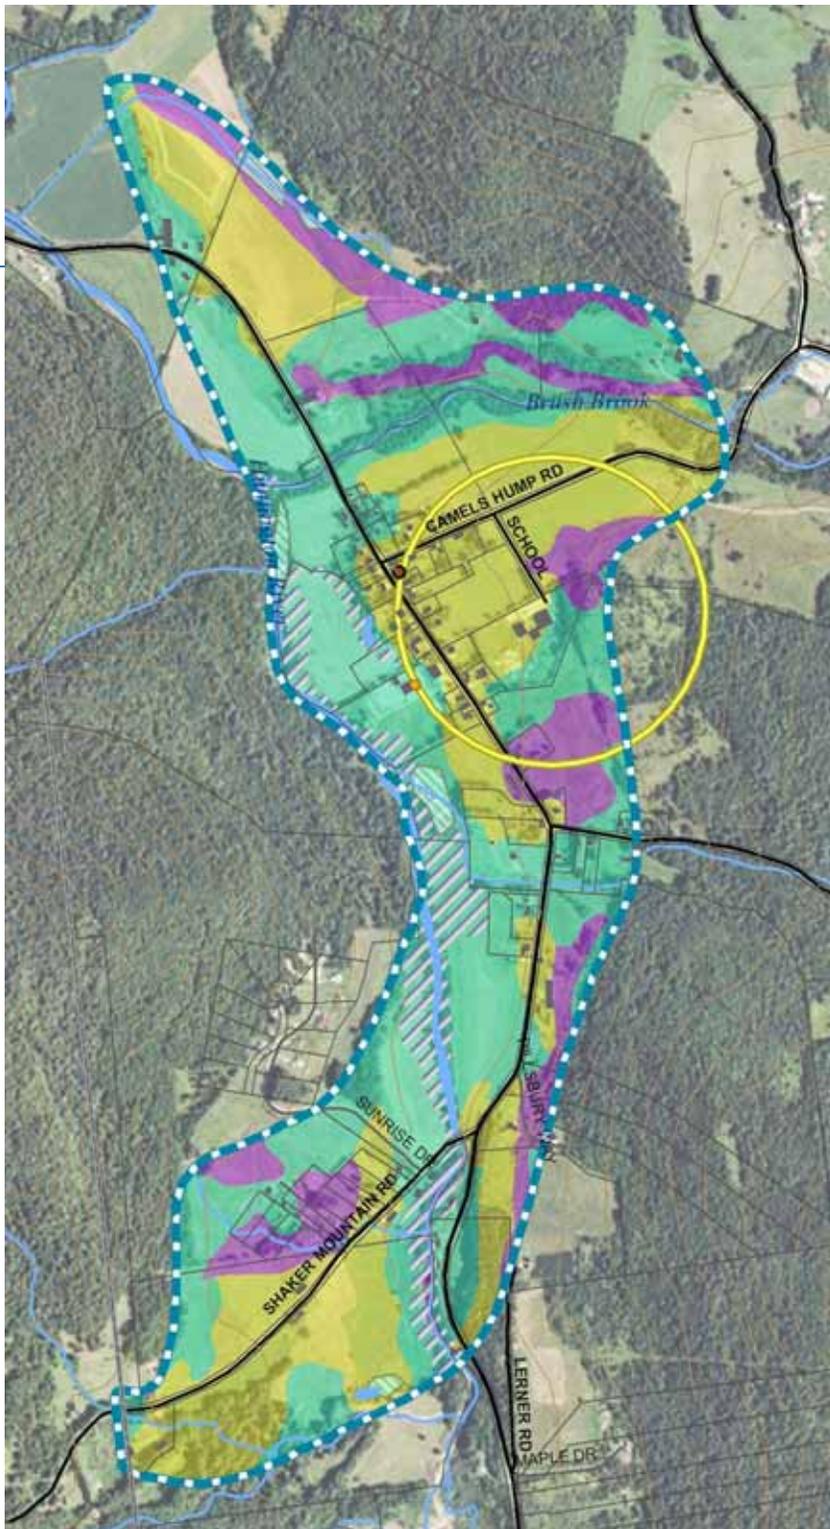
■ Huntington Center

- ~35% of soils suitable for in-ground leachfields
- Limited wetlands; less area in 100-year floodplain
- Surficial, gravel, and bedrock aquifers

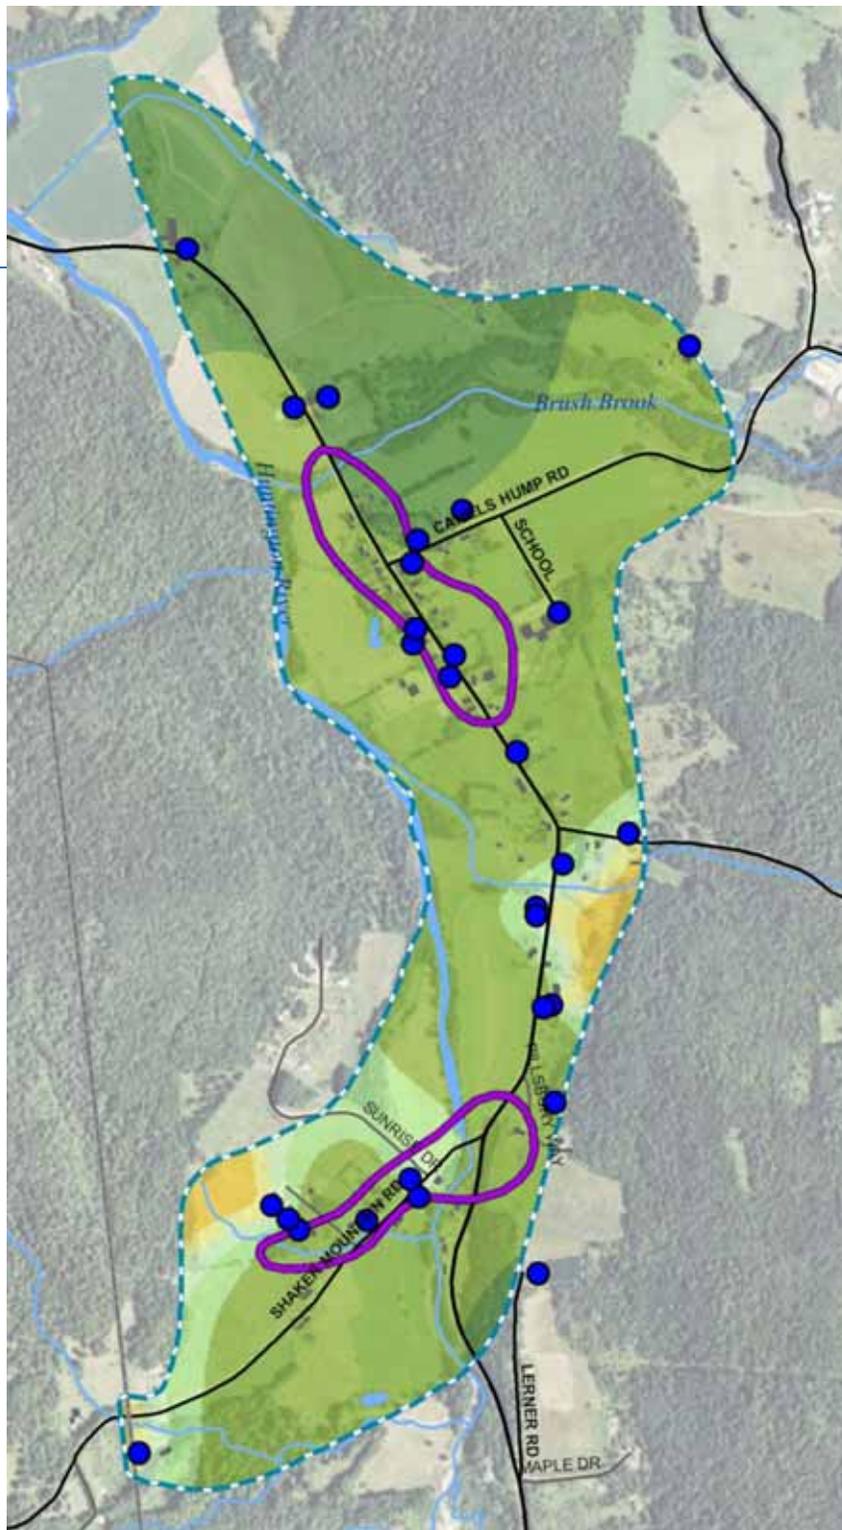
■ Huntington Center

- Very few dug wells or springs
- Drilled gravel wells are high-yielding
- Fewer, isolated areas of low-yielding bedrock wells
- Reports of water quality issues mostly aesthetic (11%), a few coliform issues reported

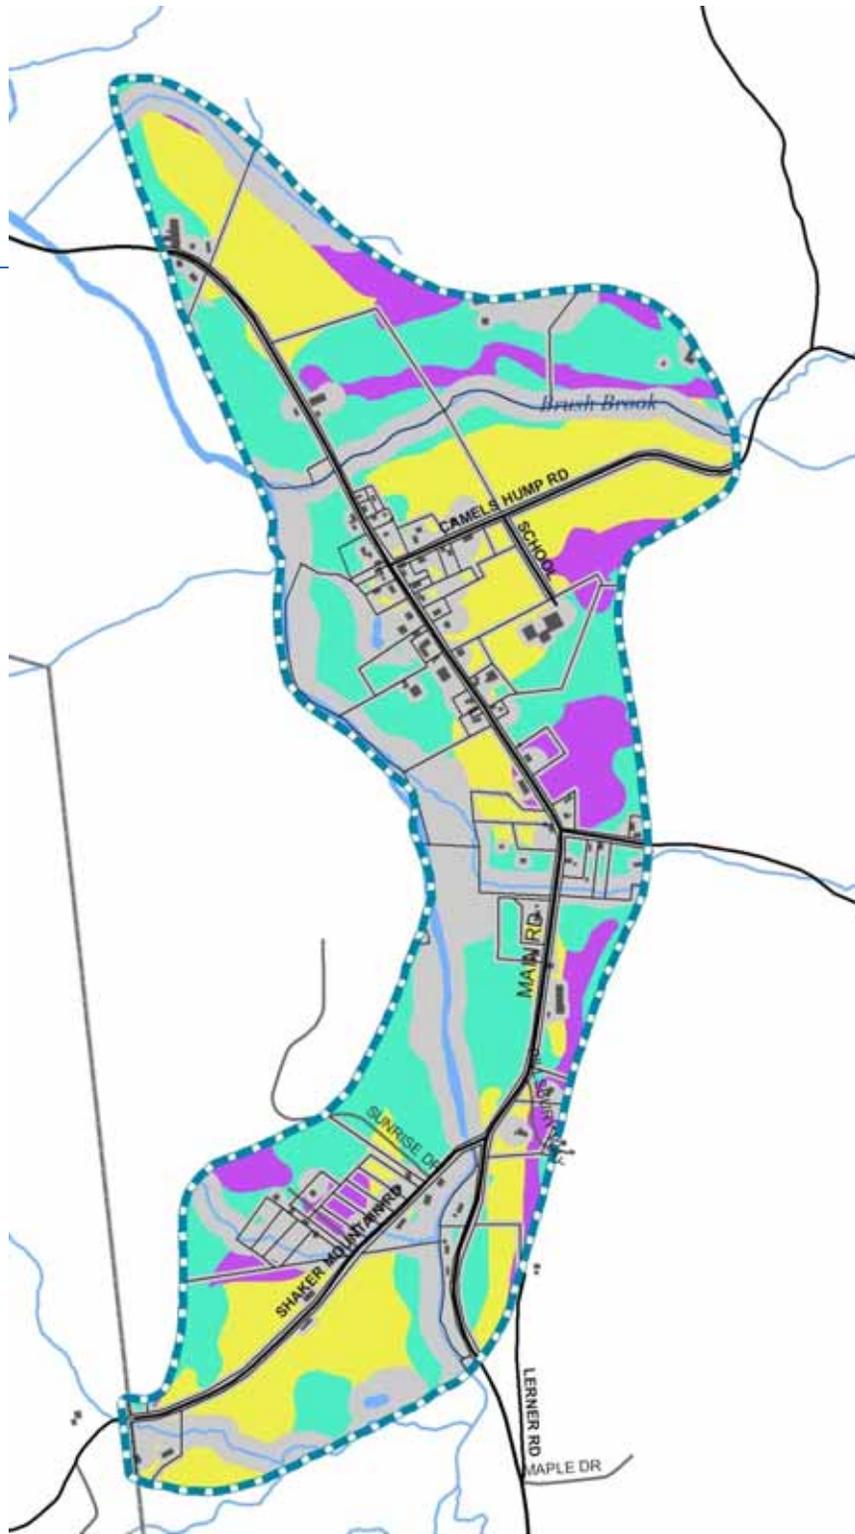
Huntington Center

- Primary environmental limitations are streams, floodplains
- Well shields are primary development-related limitation, esp. on small lots
- Several instances where future plans need wastewater capacity

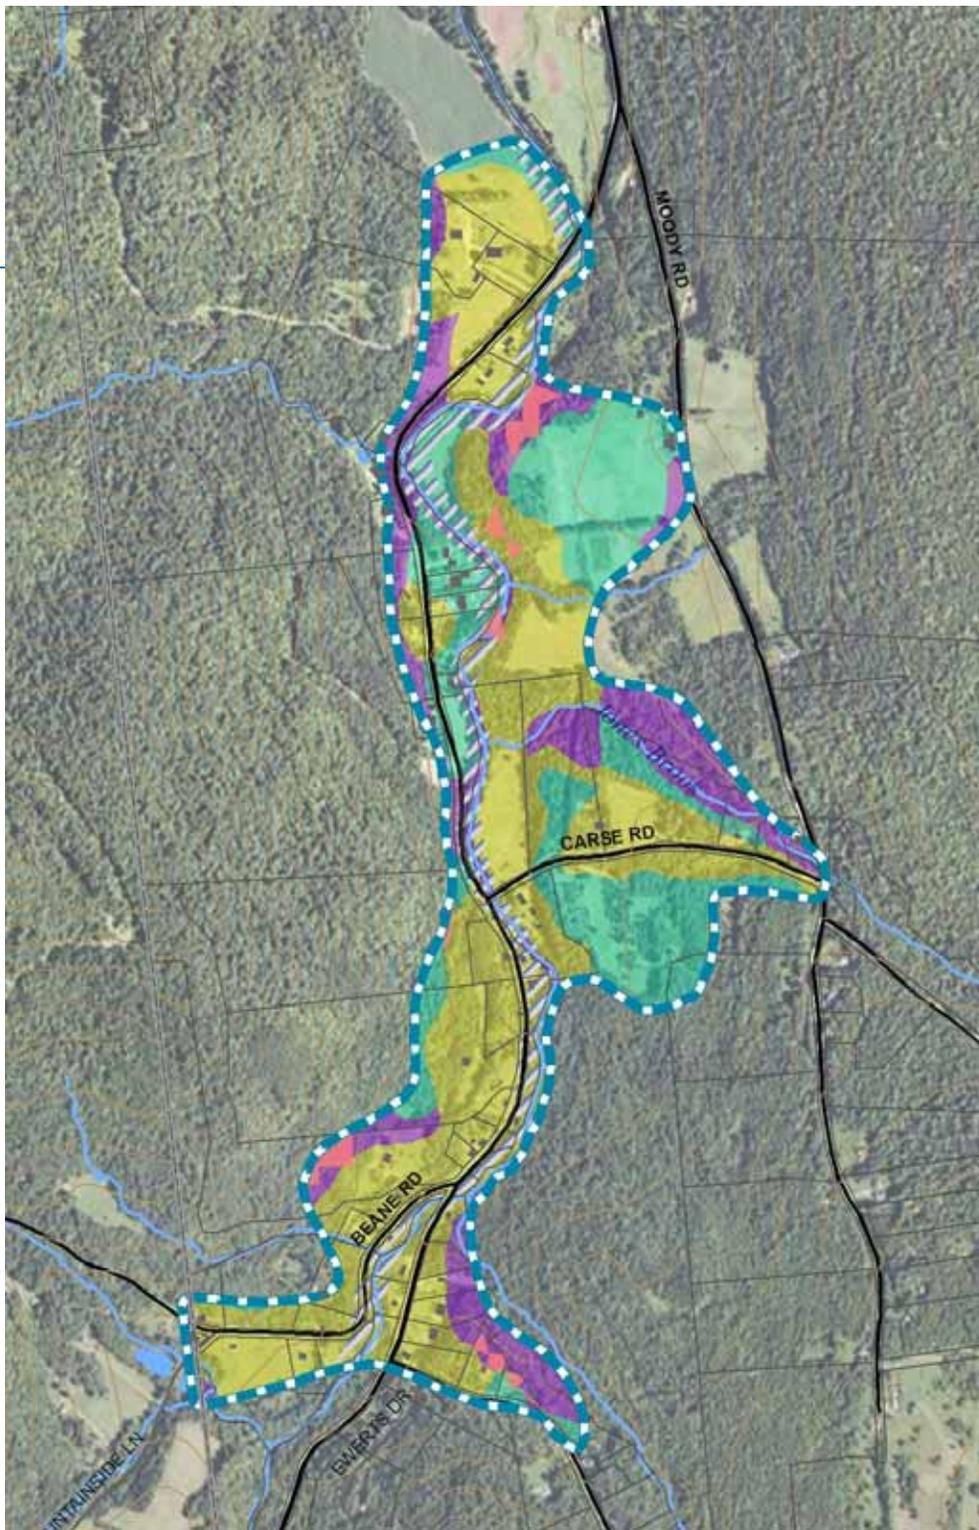
Hanksville

- 50% of soils suitable for in-ground leachfields
- Steep slopes, bedrock limiting
- Some small lots in 100-year flood elevation
- Surficial and bedrock aquifers

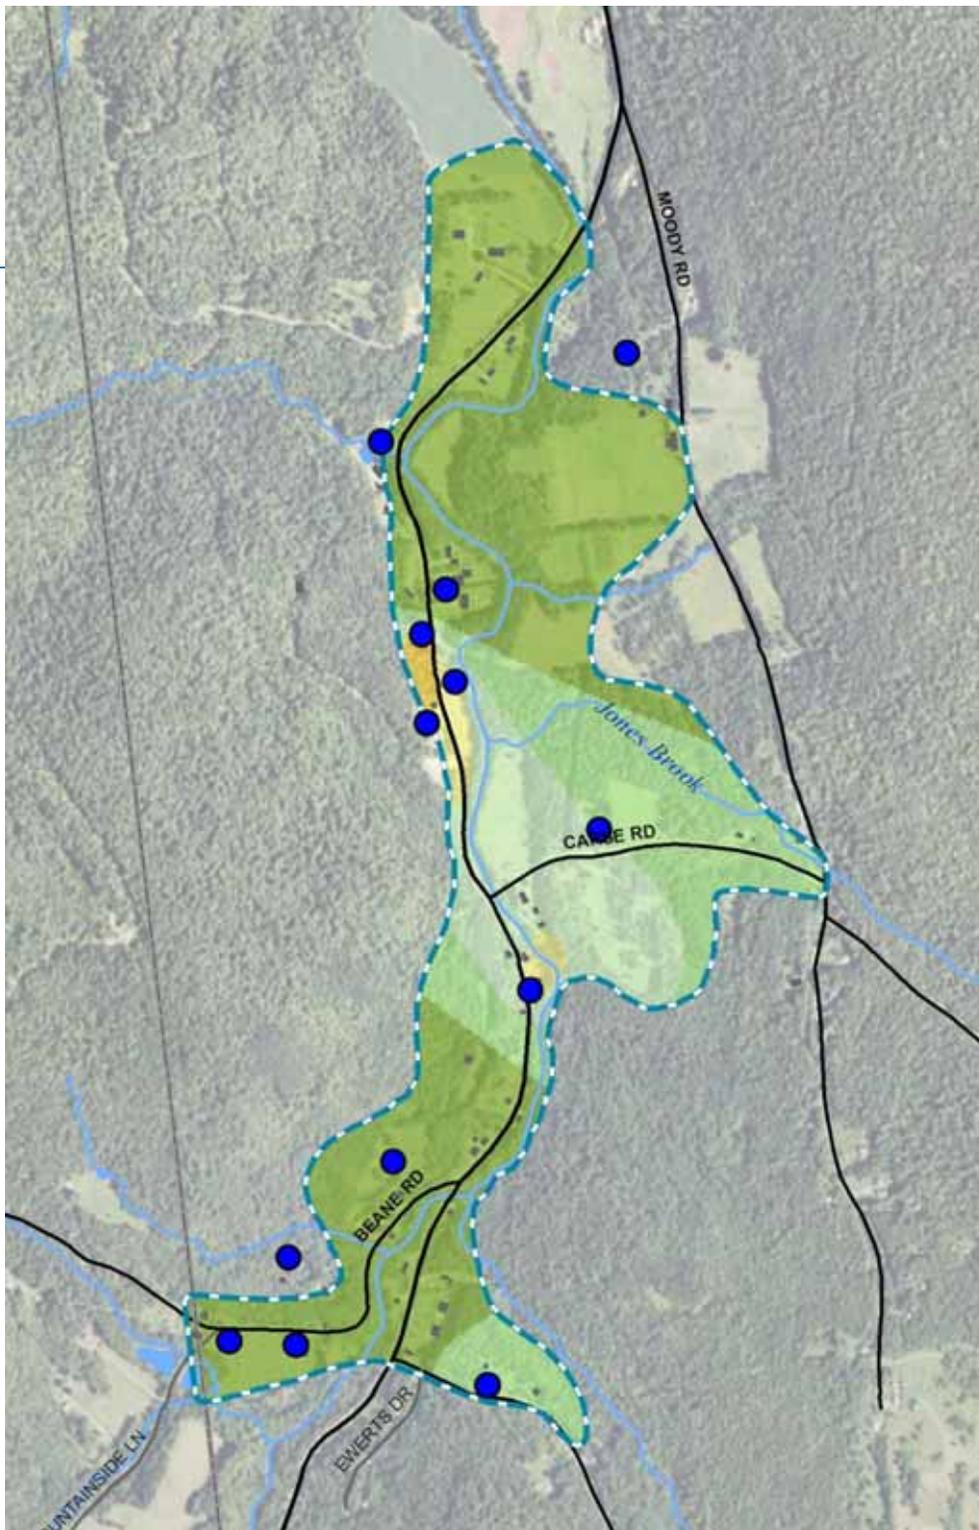
Hanksville

- Higher proportion of dug wells and springs
- No drilled gravel wells found
- Few, isolated areas of low-yielding bedrock wells
- Few water quality issues reported

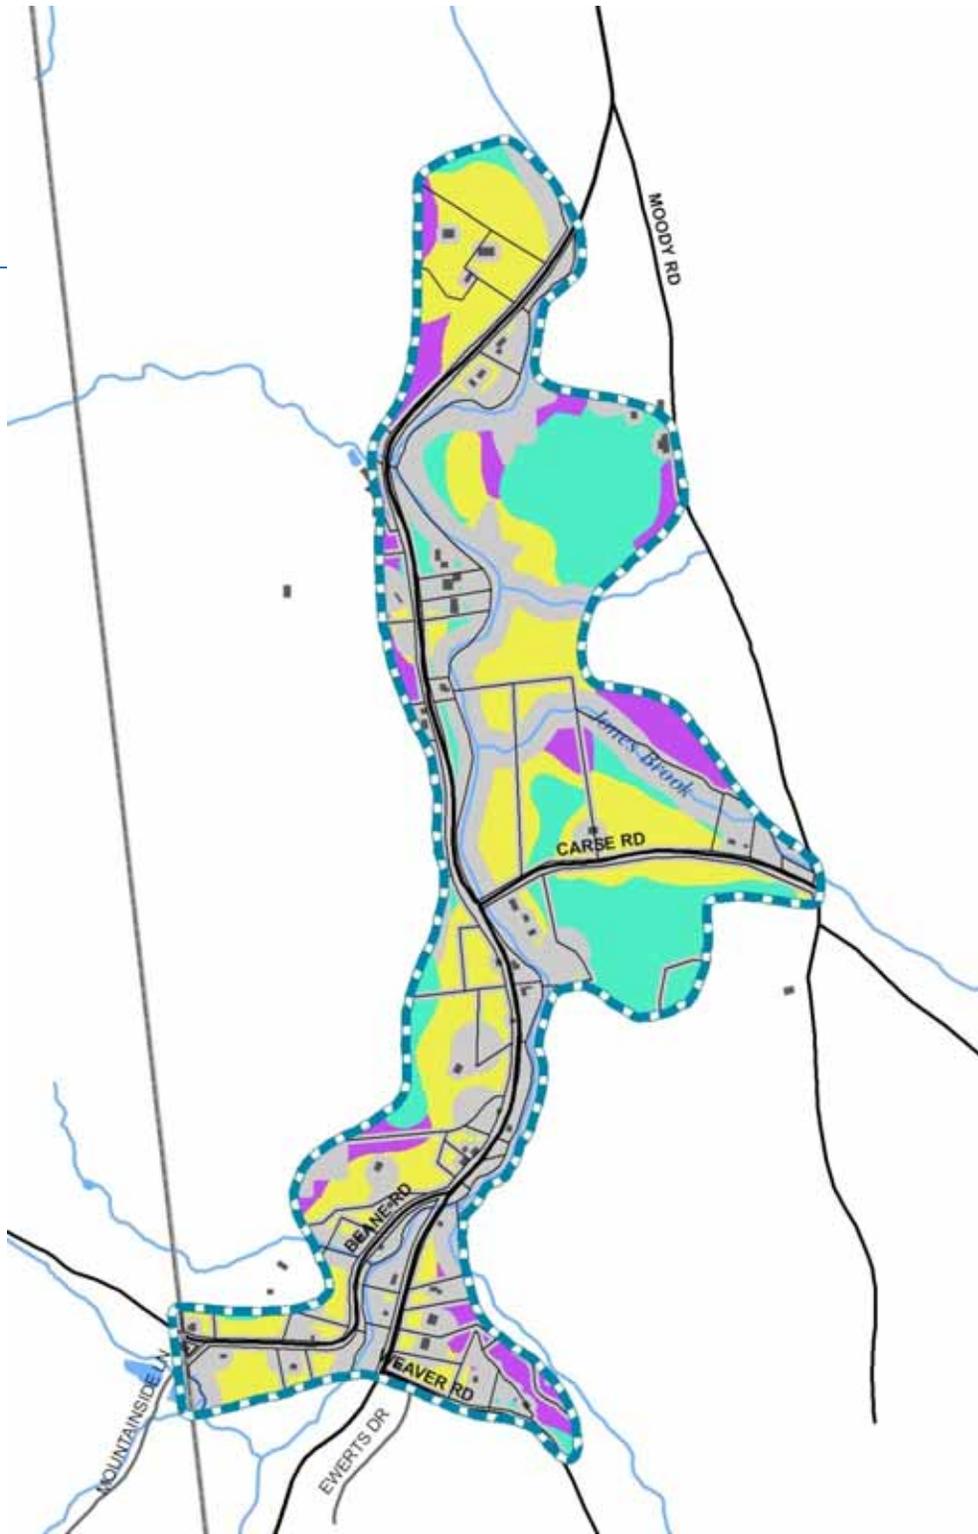
Hanksville

- Streams/floodplain, steep slopes primary environmental limitations
- Well shields primary developmental limitation for small lots – but fewer of those
- No future plans described that need capacity

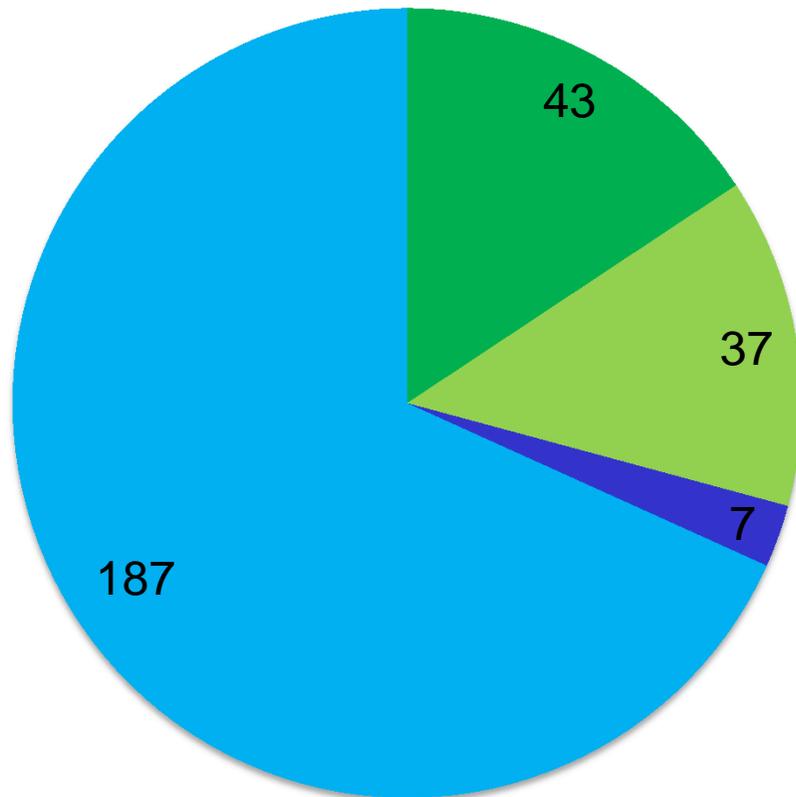
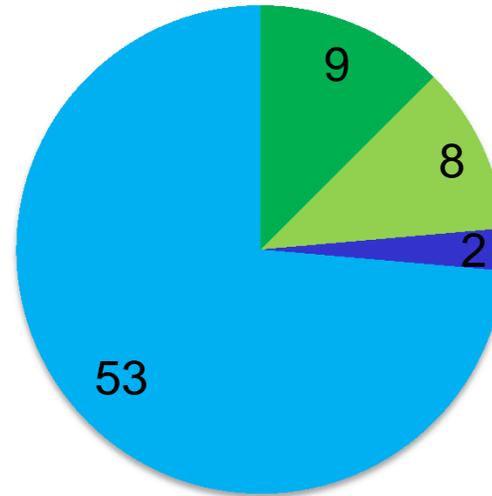
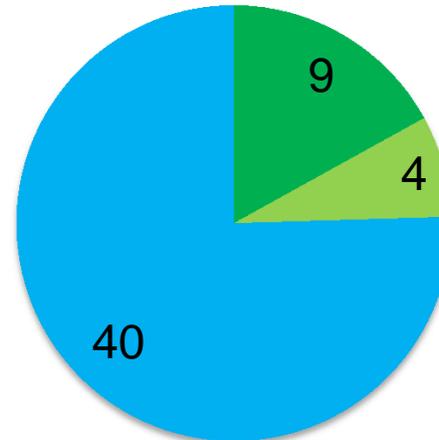
Water Supply Capacity Assessment Summary

- Low-yielding wells, or water quantity issues identified/ reported
- Water quality issues identified
- Water quality and quantity issues
- No issues identified or reported

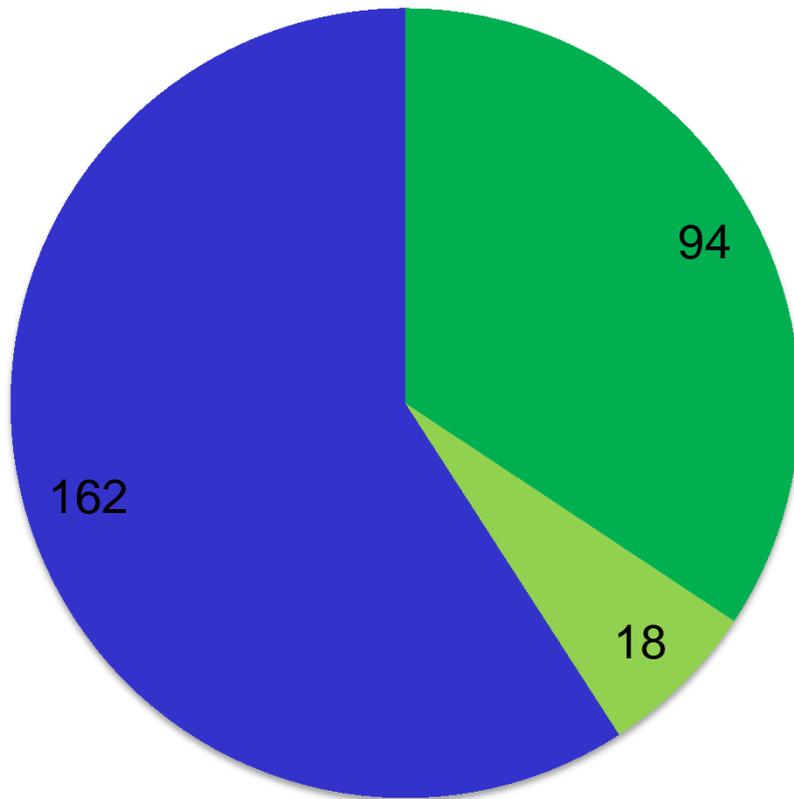
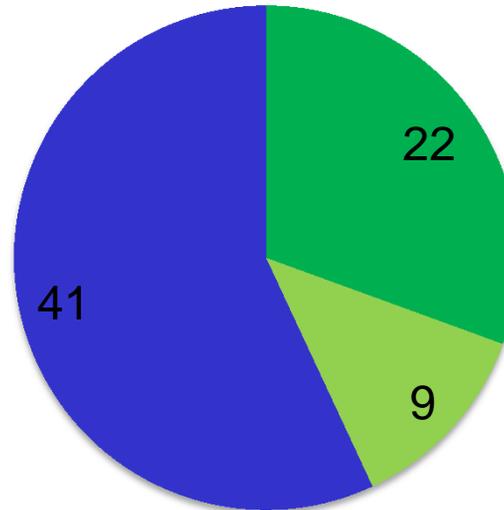
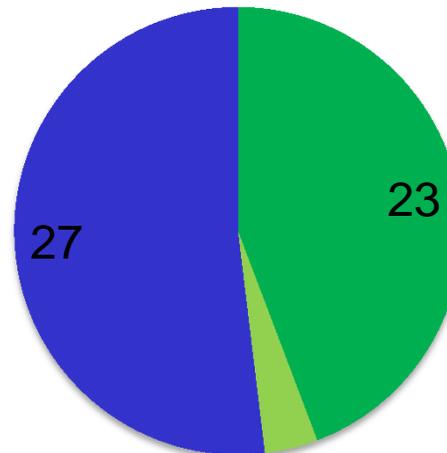
Wastewater Treatment Capacity Assessment Summary (Properties)

■ Limited area for existing system replacement

■ Currently comply, future capacity limited

■ Currently comply, additional capacity possible
