Water and Wastewater Capacity: Issues and Opportunities in Huntington's Village Districts

Lower Huntington Village, Huntington Center, and Hanksville

Amy Macrellis, Alan Huizenga, & the Water & Wastewater Working Group

November 15, 2011

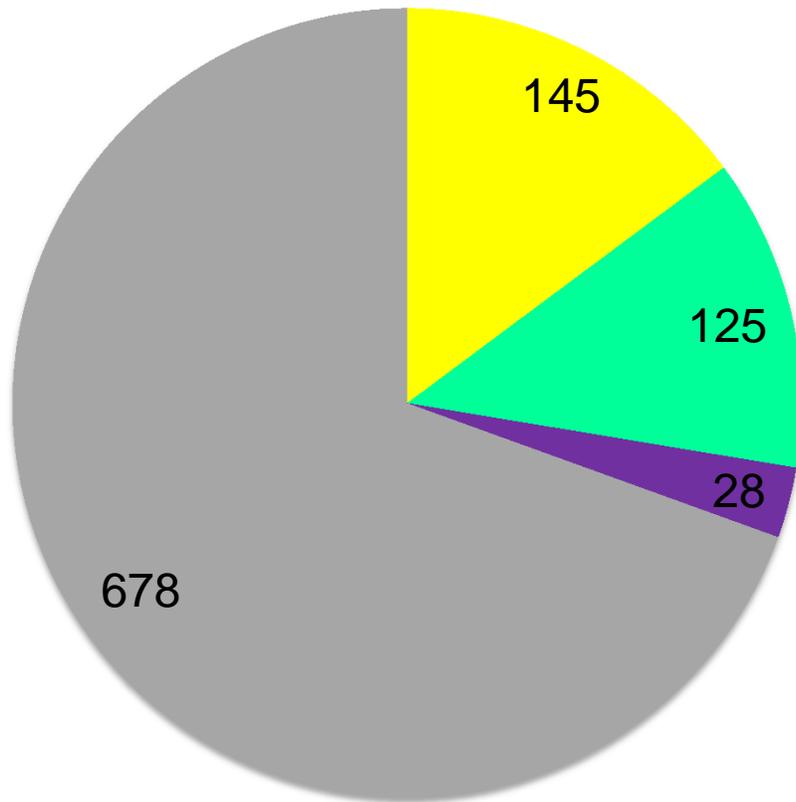
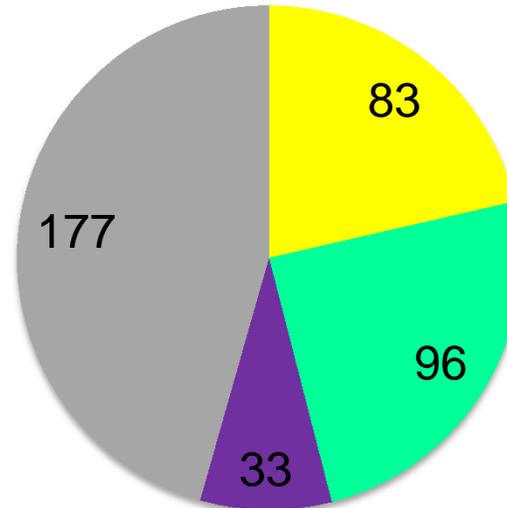
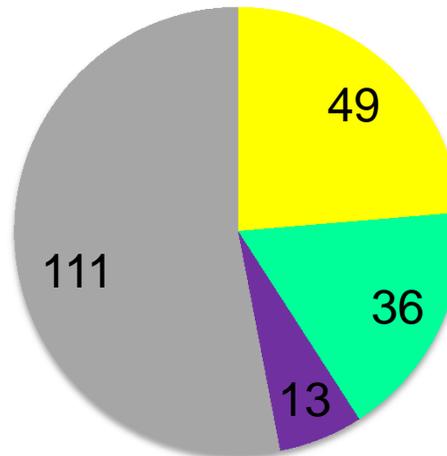
Wastewater Treatment Capacity Assessment Summary (Acreages)

- Acres Suitable for Conventional Subsurface Leachfield
- Acres Suitable for At-Grade, Mound, or Filtrate Leachfield
- Acres with Marginal Soils (Performance Based/Best Fix)
- Acres with Environmental or Development Limitations
