Huntington, Vt.

Community Tree Inventory

Trees on Town owned property

July 2005-April 2006

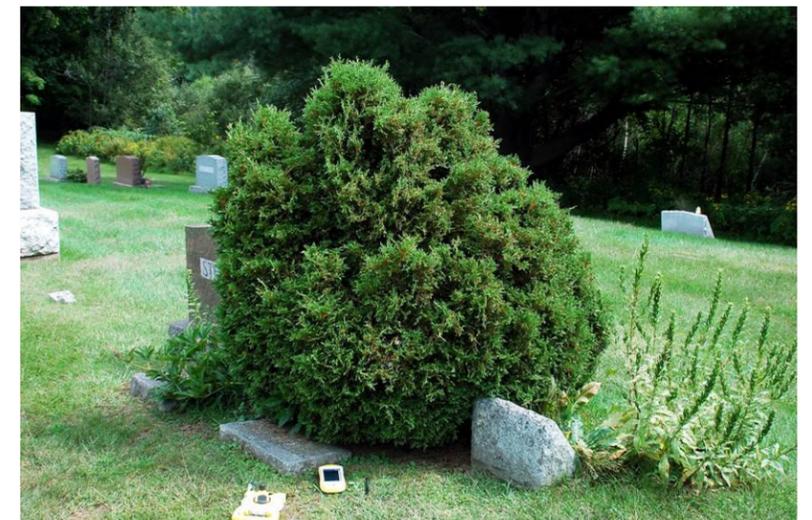
Figure c-Maplewood Cemetery

The treescapes of the three cemeteries all suffer in varying

degrees from a lack of an overall plan or planting scheme. This is to be expected as trees at these locations are generally planted by individual families wishing to memorialize a loved one. The result though is a somewhat jumbled arrangement of trees which

eventually need maintenance or in some cases cause damage or envelop the associated or neighboring stone monuments and cemetery plots.

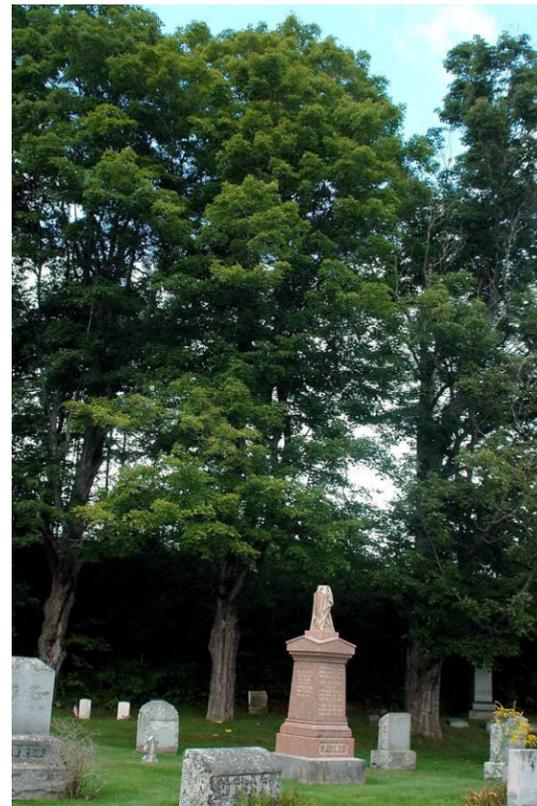
Figure h-maples of Maplewood

site. This parcel includes some of the largest and oldest trees on town property in the grand Sugar Maples lining the northern border. Also on this site is the only Silver Maple noted on town property. Of great interest, a young Chestnut seedling is located at the Maplewood Cemetery. The Chestnut was discovered by Wally Jenkins prior to the start of this inventory. It is a very small tree located within a patch of early successional forest. Chestnuts were once a dominant and important part of the Eastern US forests but have been all but eliminated by the Chestnut Blight, a fungal

While it is unlikely that the Chestnut found at Maplewood will reach maturity, it should be protected and nurtured on the off chance it does survive.

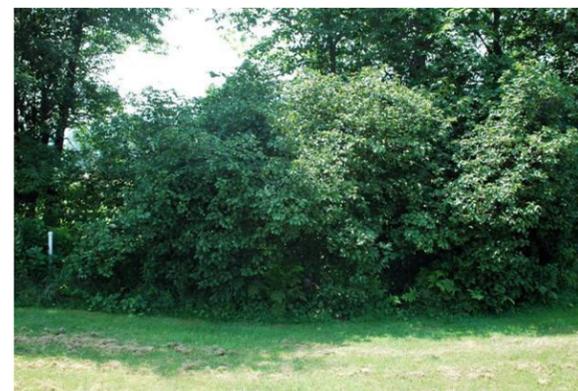
Figure m-Nannyberry at BPMS

Unfortunately this town parcel seems to have more damage to its landscape plants than other town properties. This is primarily

trunk damage from careless mowing and in many cases is extensive enough to slow the growth and perhaps cause the death of important plants. This slower growth and potential for future failure from hidden wounds is not a desirable situation on this heavily used property and replacement planting should be considered sooner rather than later.

Two preliminary suggestions for improving this large open area are as follows; a thick hedge of evergreen trees on the north property line would cut the cold wind and extend the playgrounds use in the shoulder seasons, and a copse of large deciduous trees in the middle, near the damaged Red Oaks,

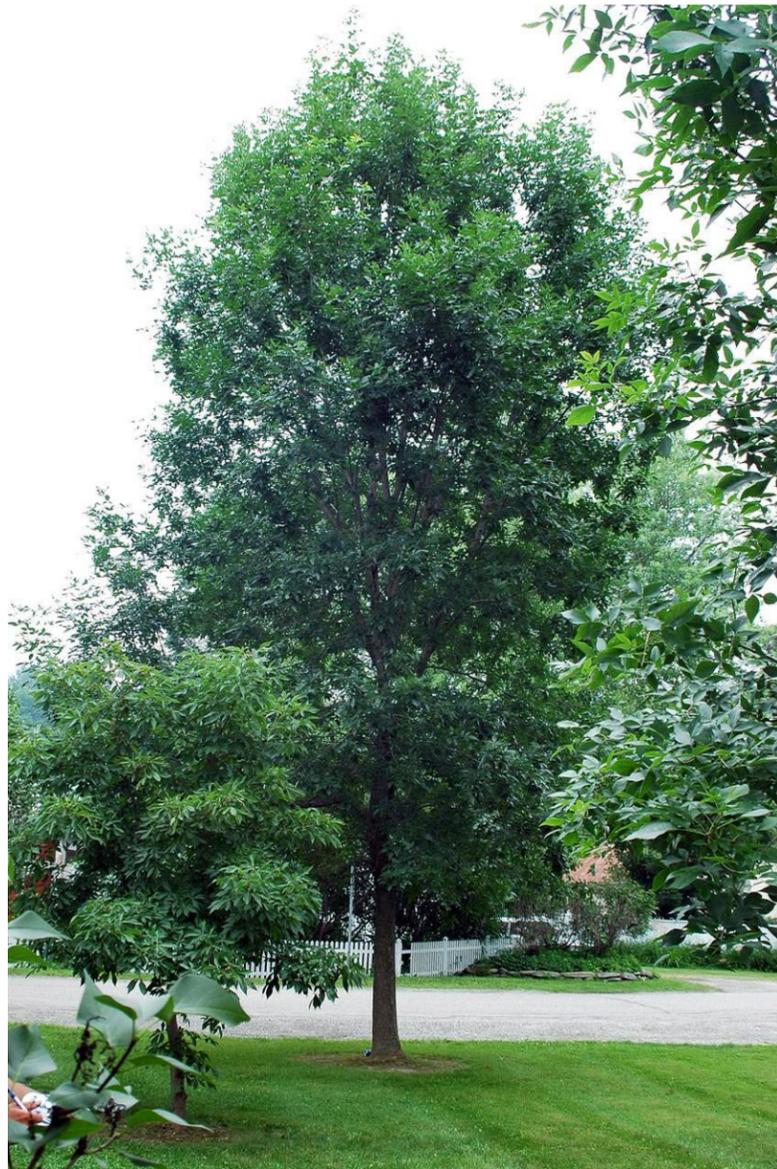
Figure o- Green Ash and Ohio Buckeye at Village Green

choices. The single-boled trunks pruned up to six or eight feet allow for easy viewing of other traffic at a potentially dangerous traffic intersection. The large tree crowns do much to screen utility line wires and poles.

The simplicity of the planting, two species of Ash trees around the perimeter and two specimens of Ohio Buckeye in the center, is by no means dull. An open park- like effect is created on a very small piece of land. The large Ash crowns provide ample and inviting shade for pedestrians and bicyclists in the summer

The crown cover provided by the Ashes is significant and as the Buckeyes grow the crown cover will be nearly complete. Any additional planting of large trees is not recommended at this time but may be necessary for replacement purposes. Like any monoculture, there are potential problems with this planting. But at the same time Green Ash, the dominant trees, are relatively salt, drought, and sterile soil tolerant. On this rough site these characteristics may make a big difference.

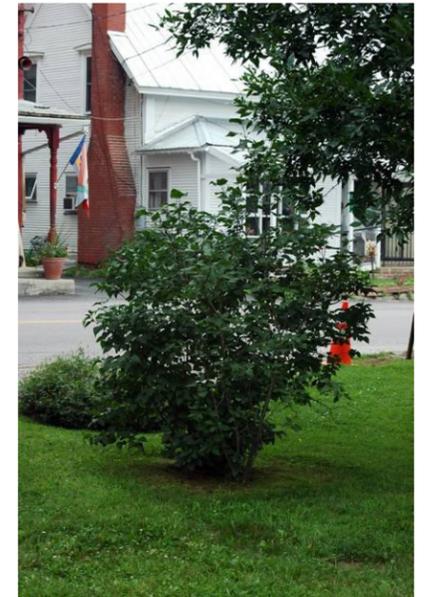
Figure q-Lilac on Village Green

The one shrub on this property is a Lilac. It seems a bit out of place, maybe even a little lonely. It would look fine in one of the cemeteries! This doesn't seem like a good property for shrubs, or at least for a small individual specimen. In terms of landscape needs the most pressing concern is the lack of winter color. Any shrub plantings should address this issue. To maintain sight lines they might be limited to an area in front of Jacques Store.

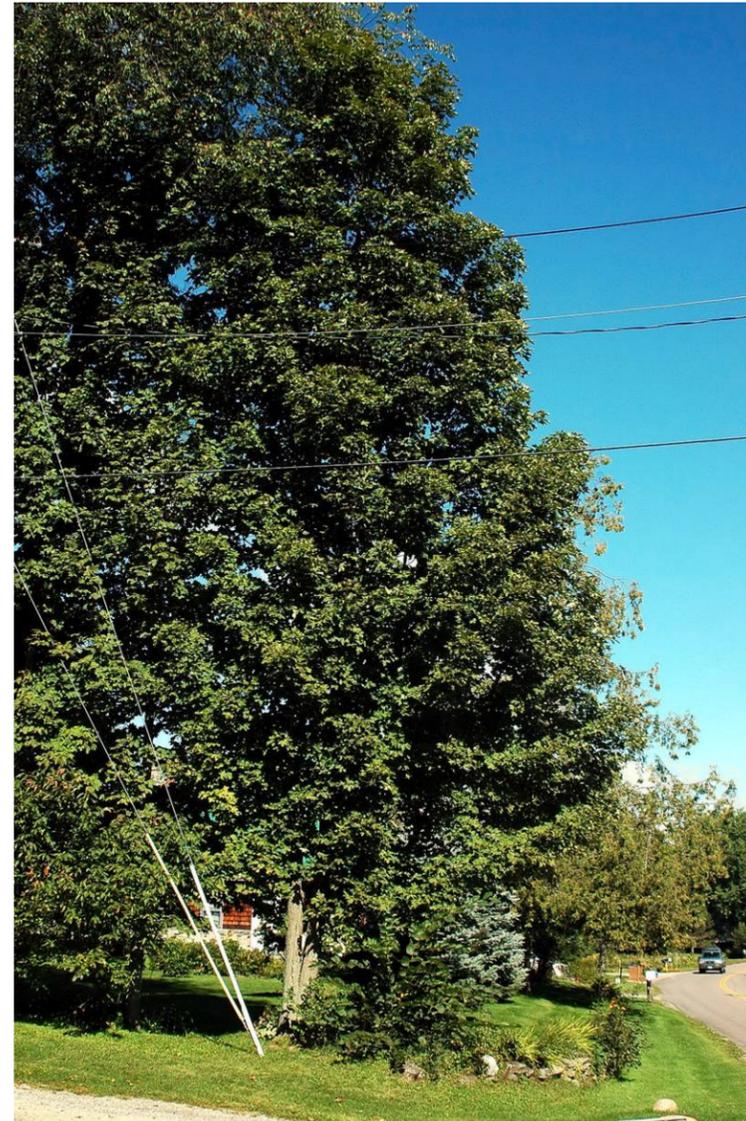
Figure s- beginning of hedgerow along UMH northern property line

There is some concern that because this hedgerow is only one tree thick in places, and some of these trees are Black Cherries

and subject to disease and dieback, there could be some significant gaps in the hedgerow in the not too distant future. Because tall trees look good here, care should be taken to protect any young saplings that may eventually replace the cherries. Any plantings to fill the voids should have height as a major requirement.

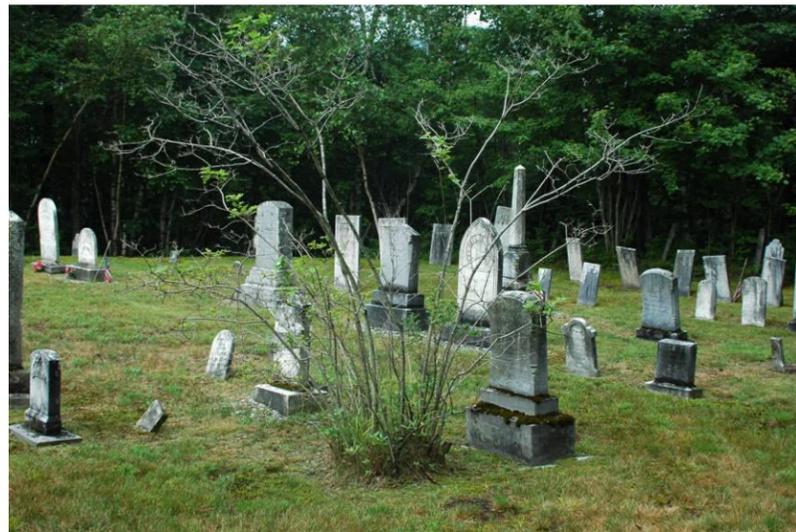
Figure u- Hydrangea at Hanksville Cemetery

cover are indicators of poor soil conditions. The woods gradually encroach through an old woven wire fence onto the site but at present most stems have been cut back. Periodically clearing the property lines of encroaching stems is a good management objective.

This property would benefit from one major addition. To enhance the quietness and bygone era feeling that is so prevalent, a shrub border on the inside of the fence is recommended. This would block the view of the fence and mitigate some of the road noise, and also give some measure of privacy to those remembering their dead. In keeping with the historical character of this spot the shrubs should be traditional specimens and not modern cultivars. In addition the shrub height should be in the four to six foot range to block the fence but not make the cemetery seem any smaller than it already is. A traditional Spirea would work well here, but there are other options as well.

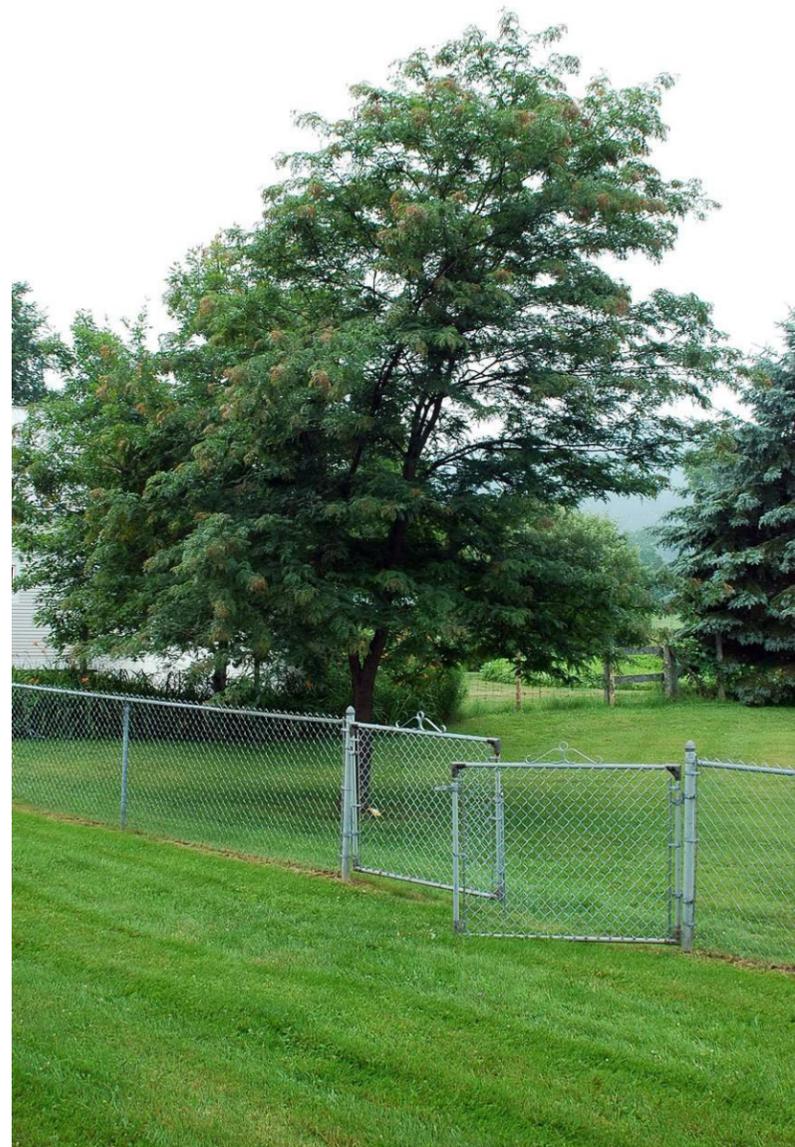
Figure w- Honey Locust at entrance to Center Cemetery

The only plantings in the western half of the cemetery are Hydrangeas. None of these are in good shape and the removal of all three is recommended. This western half is surrounded on three sides by tall hedgerows of mixed native species. Maintaining the property lines by cutting back encroaching stems should be the prime maintenance objective.

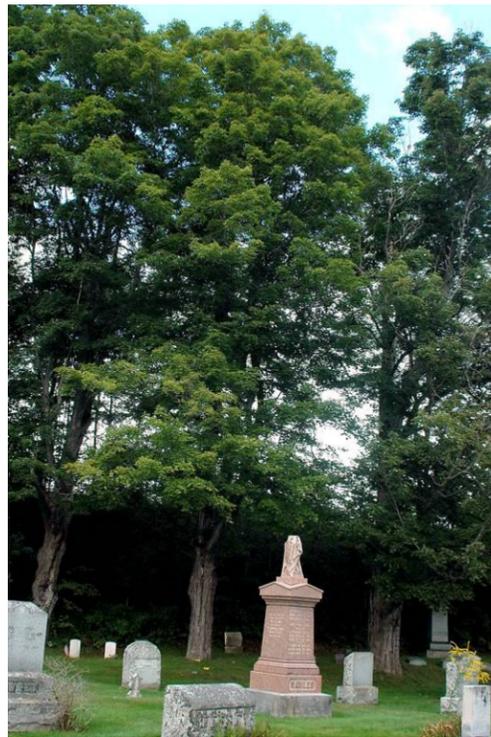
Figure aa- some of the Maples of Maplewood

row of grand old Sugar Maples on the north side of the lower section, and a couple of young Red Maples have been planted near the entrance. And at the top of the hill a Memorial Tree Area has been established and this is being planted to Sugar Maples.

This cemetery has one problem that is not found to such a great extent in the other two cemeteries in town. Here we find some situations where tree or shrub plantings on individual lots have grown too large and are obscuring or damaging headstones. This requires regular maintenance to keep things in check, and even then the rampant growth can soon makes things unsightly. It is

easy to see why the cemetery guidelines now state that there are to be no permanent plantings (trees or shrubs) without approval.

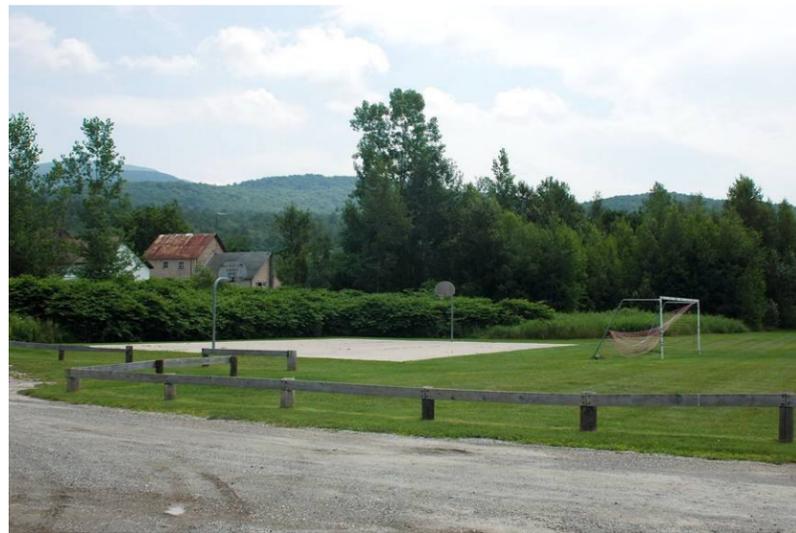
Figure cc- looking south at Rec. Field

This is the only town property bordering the Huntington River and as such warrants some careful planning. Currently the hedgerow along the river serves as a waste ground and dumping station. Cleaning up some of this mess is the first step in making this area more appreciated. A much wider hedgerow is also very desirable. This would help provide more shade for the river, improving fish and wildlife habitat. And it would help prevent serious erosion from flooding. Using the Audubon Center River

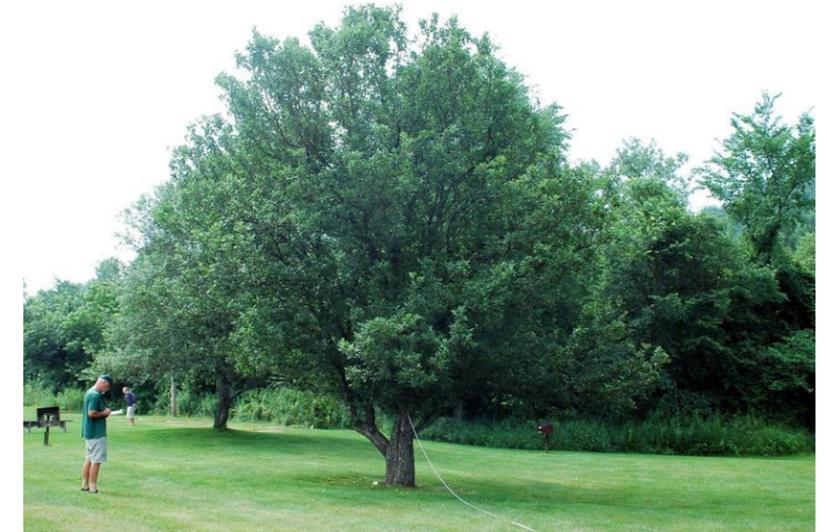
Figure ee-Apple tree at Recreation Field

Protection and enhancement of the river experience here is of primary importance. After this, as time and funding become available, planting some large shade trees at strategic locations is most desirable. A few of these trees near the gazebo and screening the horseshoe pit light pole would work well, and a few near the basketball court would be

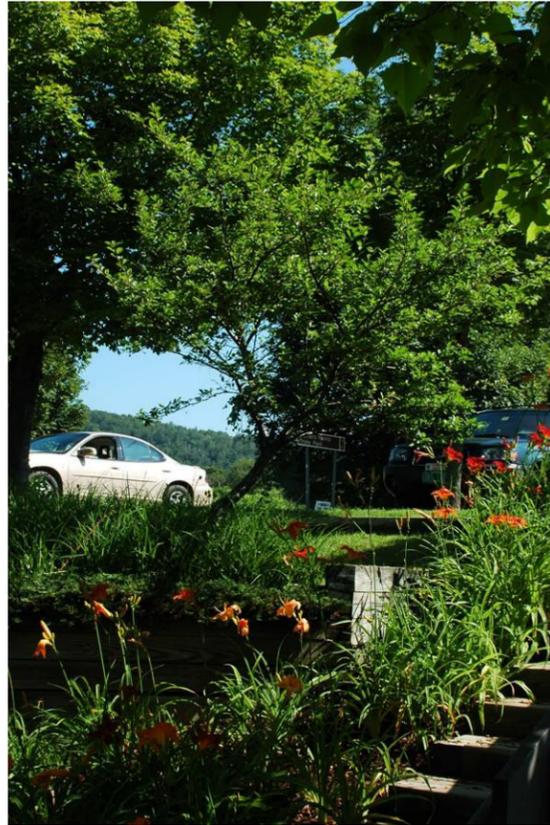
Figure ff- looking through trees between Town Office and Fire Station

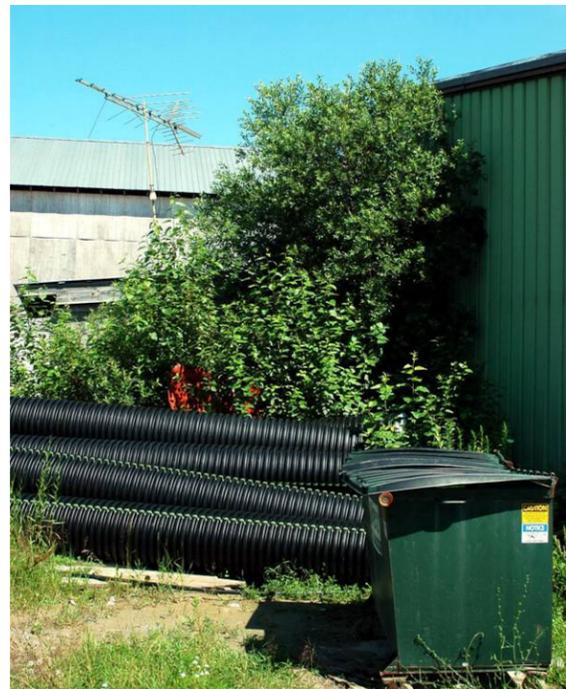
Figure gg- trees close to the Town Garage

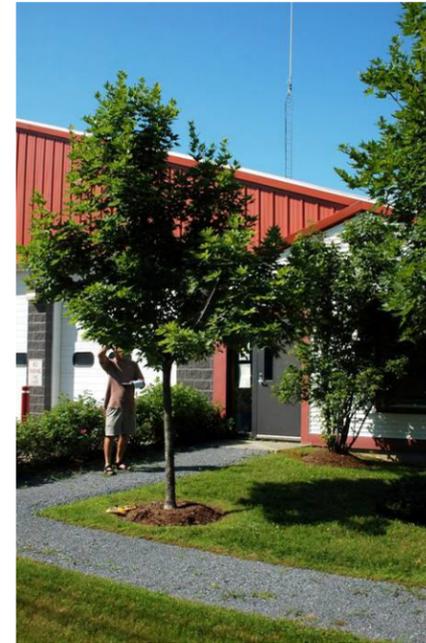
The landscaping on this property seems very cohesive and complete and regular maintenance of the existing trees and shrubs is all that is needed. The only cause for concern at this time is the badly damaged

Figure hh-Maples in front of the Fire Station

trunk on one of the Sugar Maples in front. Since this is an area of heavy pedestrian and vehicular traffic, it might be best to remove this tree now to avoid potential problems in the future.
